Herøya Industripark - Porsgrunn

Historical Research on the Possible Presence of Unexploded Ordnance

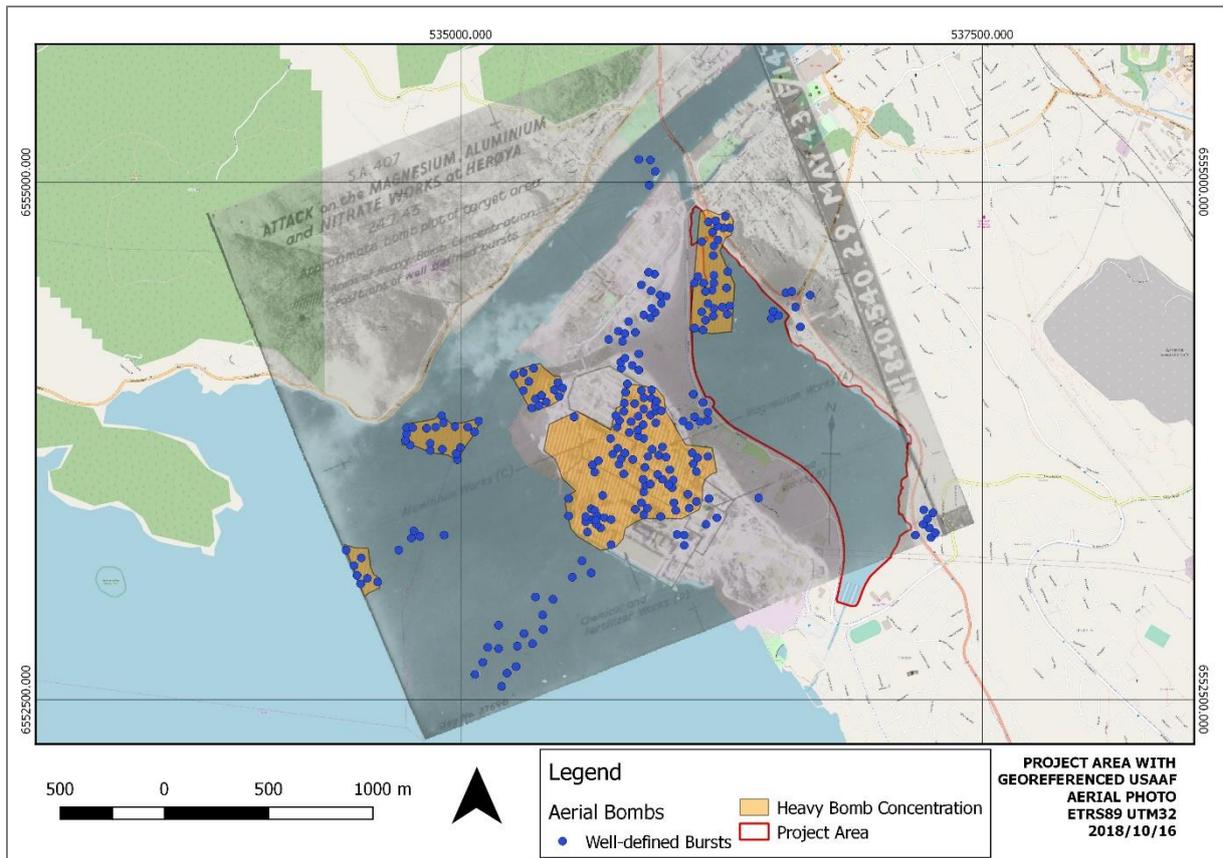
Figure 7: Map of project area with aerial photo from Figure 6 georeferenced and superimposed. Note the blue dots of well-defined bursts and orange areas of heavy bomb concentration (ADEDE and USAAF Interpretation Reports)

The aerial photo from the USAAF Interpretation Report No. SA-407 (shown in Figure 6) was georeferenced and then superimposed over a current map of the project area. The bomb bursts and areas of heavy concentration were traced over so as to be easier to read (see Figures 7 and 8). If the blue dots (each showing a “well-defined burst”) in the Gunneklevfjord are counted, then a total of 25 well-defined bursts landed in the fjord itself. Even if each blue dot would only represent a single bomb, that would add to a total 12,500 pounds of explosives (each bomb being 500 lbs). However, that is not taking into account the fact that the Gunneklevfjord used to be larger (see Figures 9 and 10 for comparison). The peninsula was expanded in the meanwhile since WWII. Observing the aerial photo from Figure 6, and counting the number of dots that fall into the former fjord, the number rises from 25 to 42. If each dot is still only one bomb, that would amount to 21,000 pounds of explosives (see Figure 10).

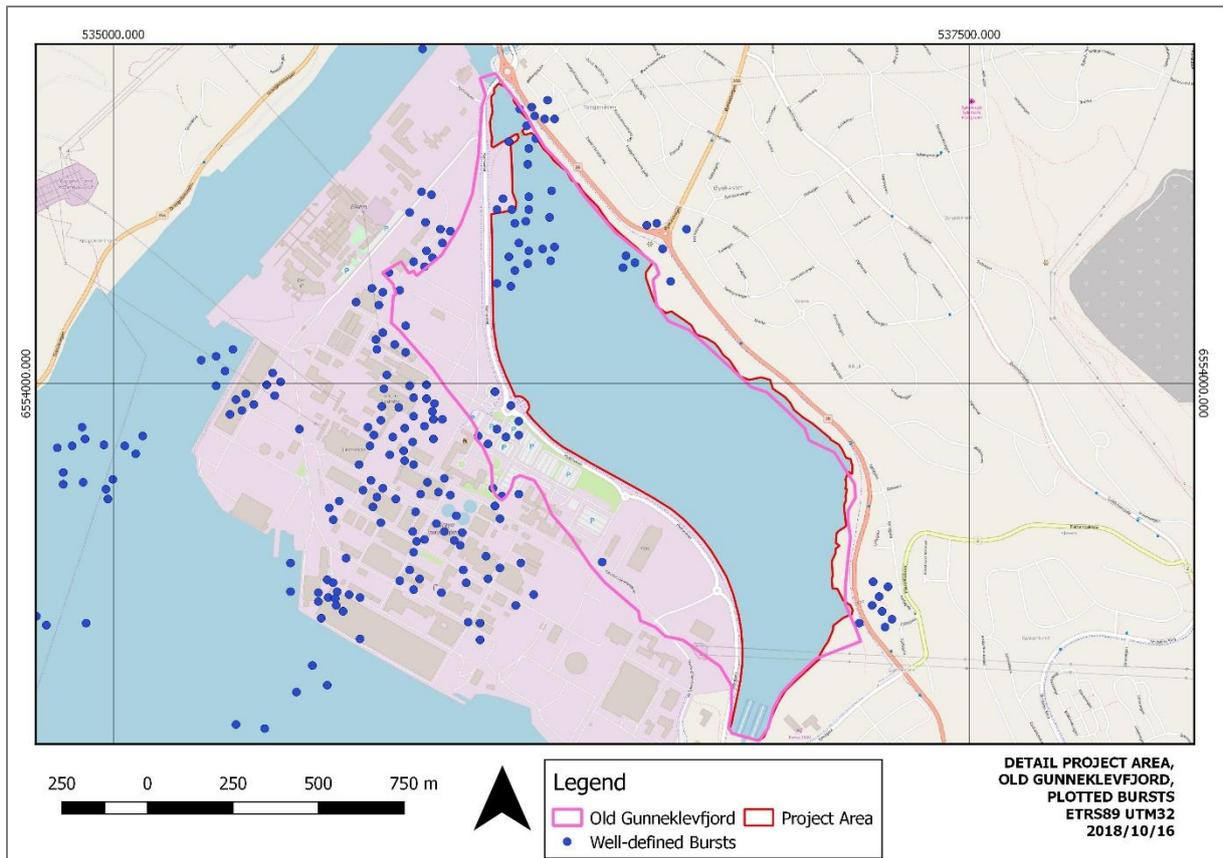
Figure 10: Detail map showing the project area in red, the old Gunneklevfjord in pink, and the plotted bombs from the USAAF report picture. (ADEDE and USAAF Interpretation Report)

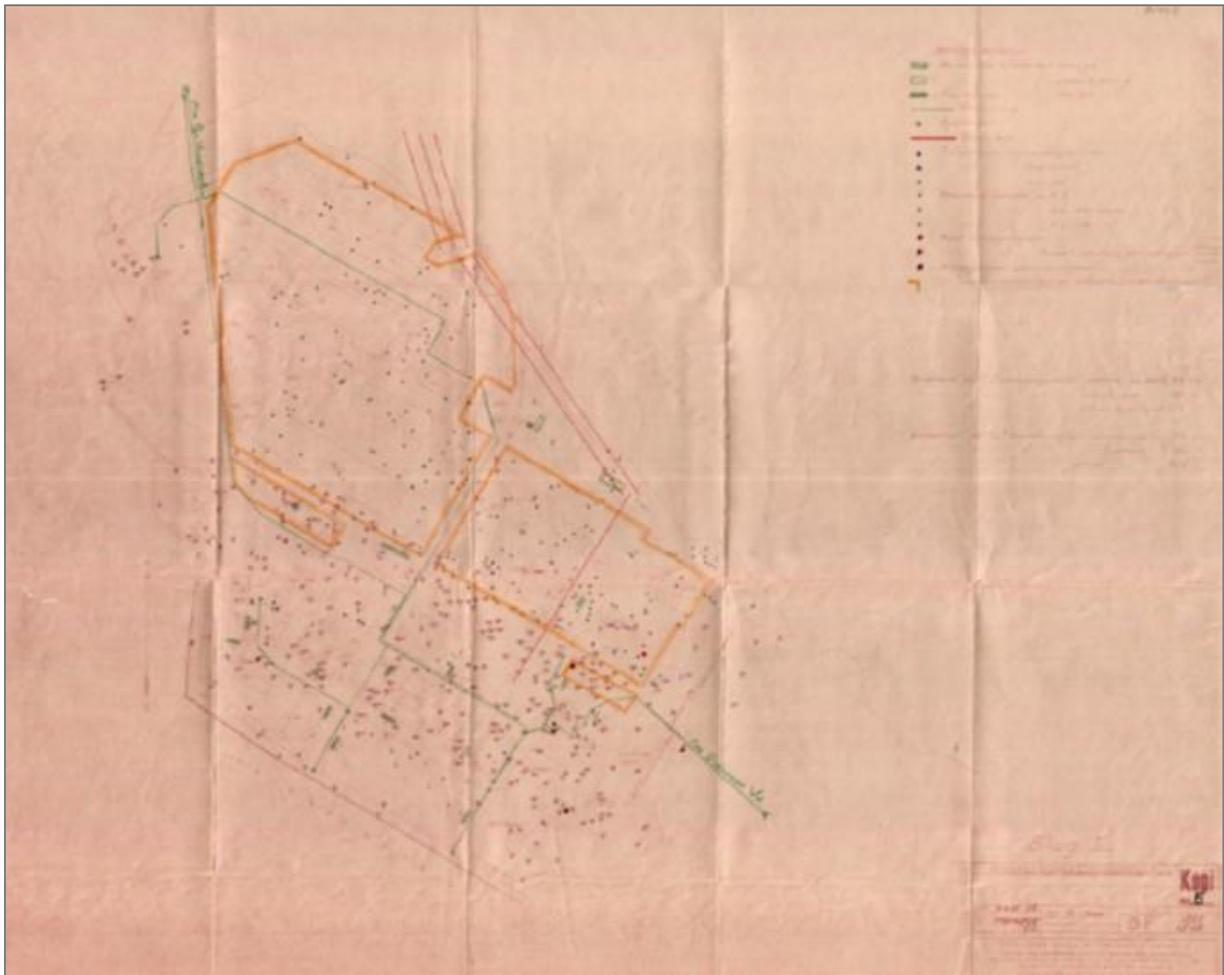
Figure 14: Map from report issued by Eidanger Salpeterfabrik, showing recorded locations of bomb hits and UXO

The pink map shown in Figure 14 depicts the peninsula of Herøya with “bombtreff” (bomb hits) plotted. Figure 15 is a detail from the map legend of Figure 14. The legend lists bomb hits on Eidanger Salpeterfabrik (“E.S.”) as well as Norsk Lettmetall (“N.L.”), and lists bomb hits found in buildings (“i bygninger”) and outside of buildings (“utenom bygninger”). Tallying these numbers, the report states that at least 580 bombs fell on these two factories.

The Eidanger report created lists and maps to record the location of each crater and unexploded ordnance. In total, the lists in the report tally roughly 314 bomb craters, 40 bomb hits, and nine UXO.²² Of these, specifically in the area of “Gunneklev”, the report lists 54 instances of observed craters, three UXO, and 17 bomb hits.

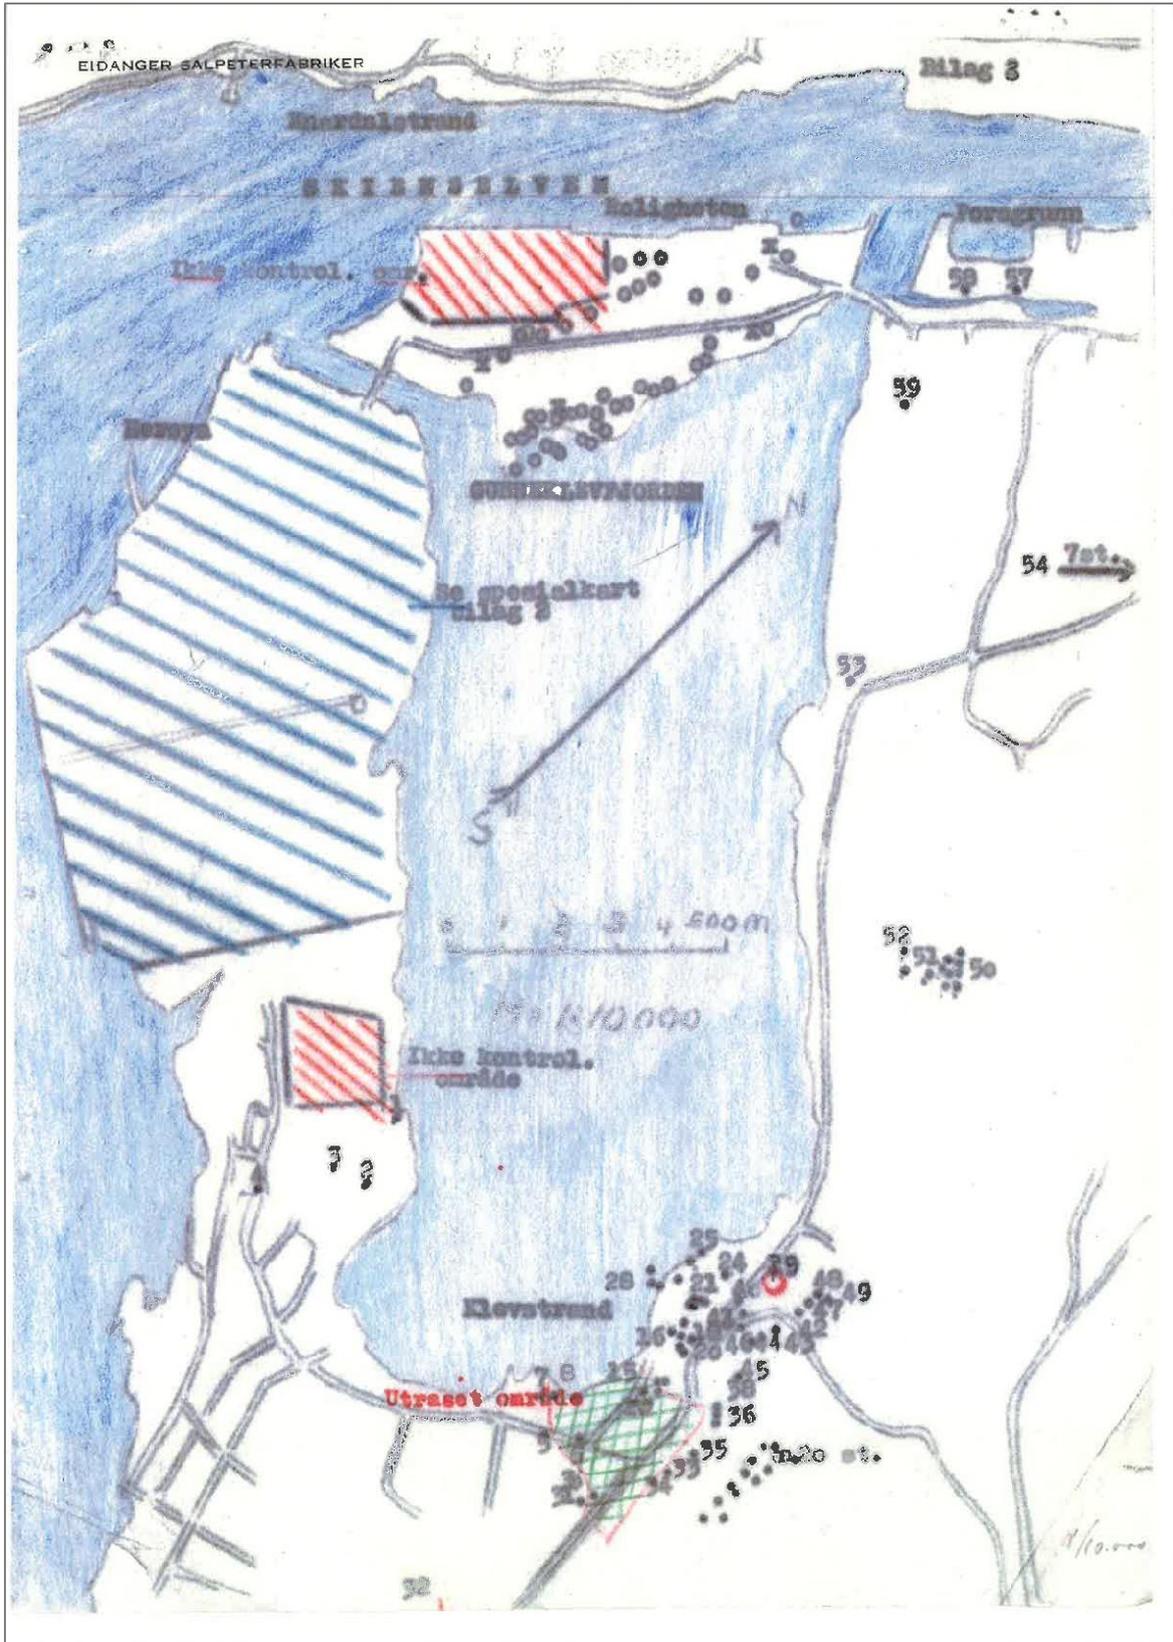
The Eidanger Salpeterfabrik report also mentions the landslide at Gunneklevfjord, in the appendices listing damage and bomb craters in the area of Gunneklev: "*Terrenget er sunket ned langs fjellsiden ca 8 m.*"²⁷ In addition to this, in a sketch of the Gunneklevfjord included in the report, the cluster of bombs in the southeast is clearly depicted. There is also a hatched area with the note "*Utraset område*".²⁸

Figure 18: Sketch included in the report issued by Eidanger Salpeterfabrik. Note the hatched area in the south of the fjord, with the words "Utraset område". This was probably the location of the landslide. *Rapport fra Eidanger Salpeterfabrik*

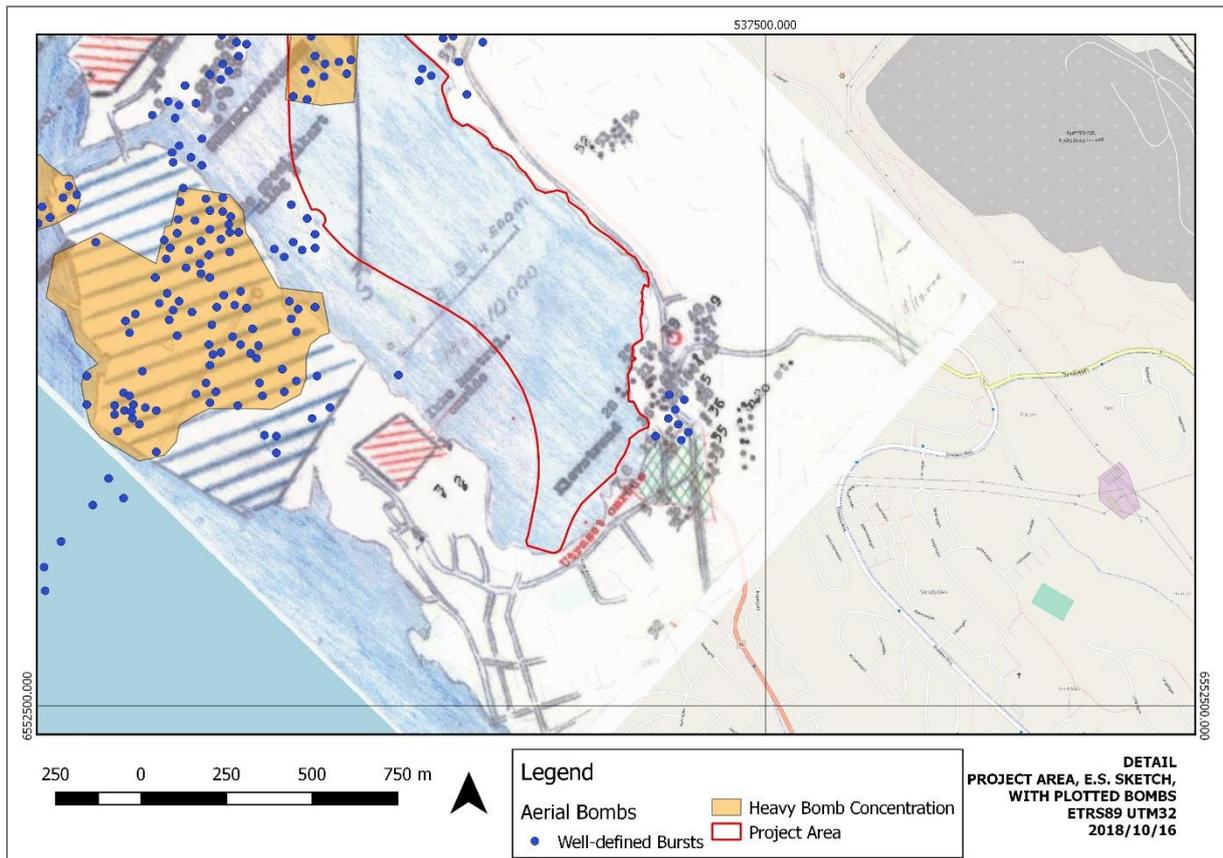
Figure 20: Detail of Figure 19, with the plotted bombs from the USAAF report superimposed.
(ADEDE, USAAF Interpretation Report, Eidanger Salpeterfabrik)

It can be concluded that there exists the possibility of UXO having ended up in the southern part of the Gunnekelevfjord. More than one source refers to the considerable landslide, a landslide directly caused by the bombing of 24 July 1943. Since no methodical clearance of the Gunnekelevfjord has yet been performed, the risk of encountering unexploded ordnance in the fjord is high.

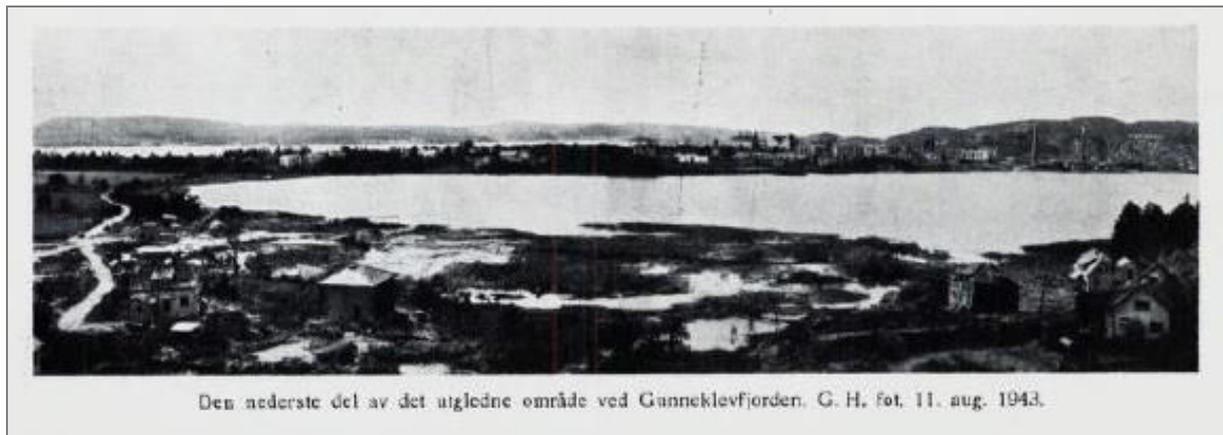
Figure 21: Photo of Gunneklevfjord after the landslide (11 August 1943). Caption reads: "The lowermost area of the landslide at Gunneklevfjorden"²⁹

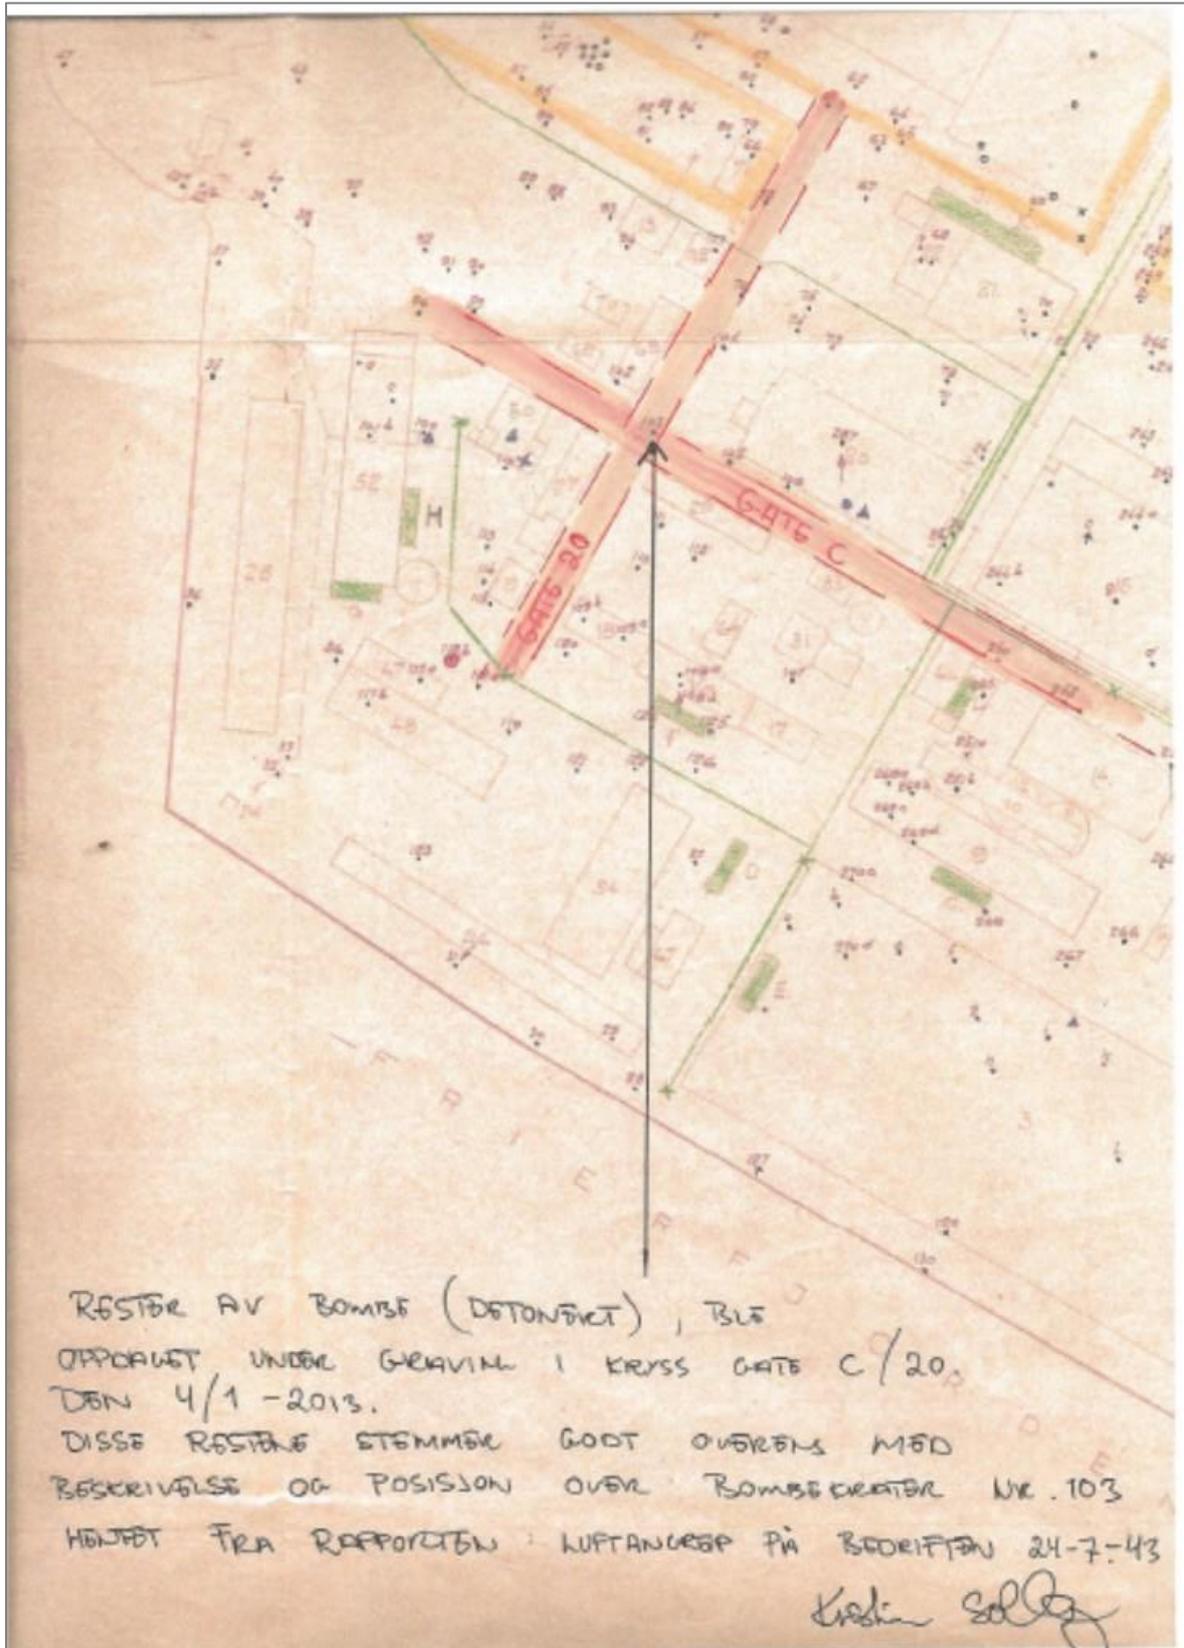
Figure 33: Appendix to report from Eidanger Salpeterfabriker, describing the location of discovered UXO after the 24 July attack⁶²

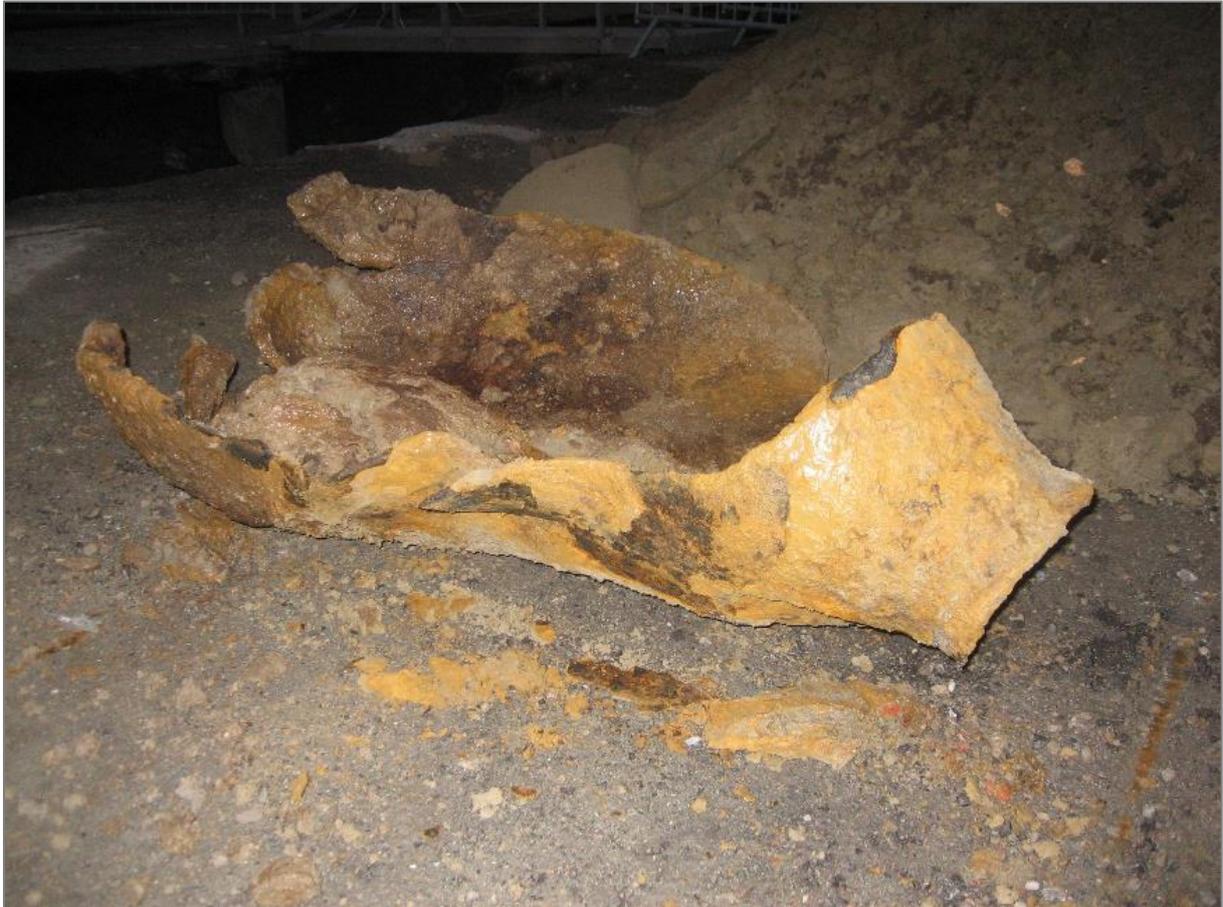
- On the 4th of January 2013 parts of a (detonated) bomb were discovered when digging at “crossroad C/20” (see Figures 33, 34 and 35). This confirms that the position of “crater 103”, as described in the report released by *Eidanger Salpeterfabriker* is fairly accurate.
- On the 25th of July, 1943, German AA projectile splints were recovered from a beach (Figure 35).
- On the 14th of September 1982 an Impeller from the fuse of a US bomb was found.
- In 1982/83, the industrial park reported the discovery of parts of US 500 lb bomb, as well as splints. These were found in a storage at Herøya during a clean-up.

Figure 34: Photo of a detonated bomb recovered at Herøya. The bomb resembles a US M43 500lb bomb.⁶³

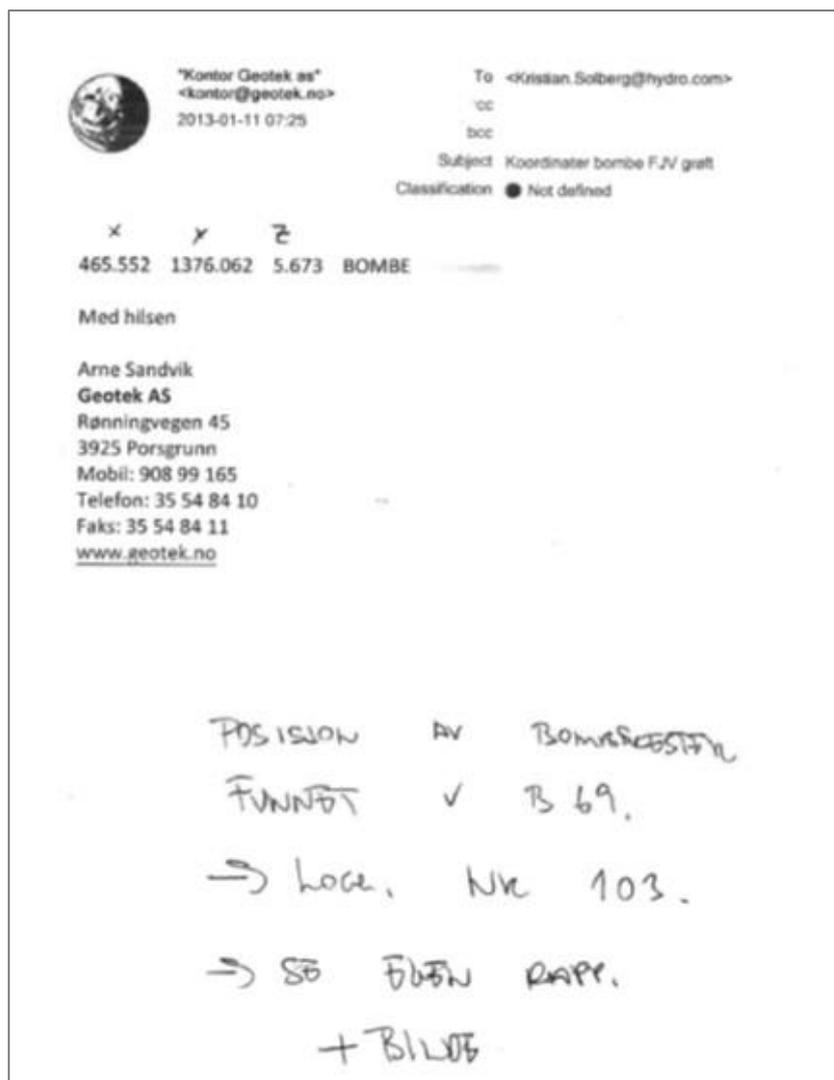
Figure 35: Report of bomb discovered on the 4th January 2013⁶⁴

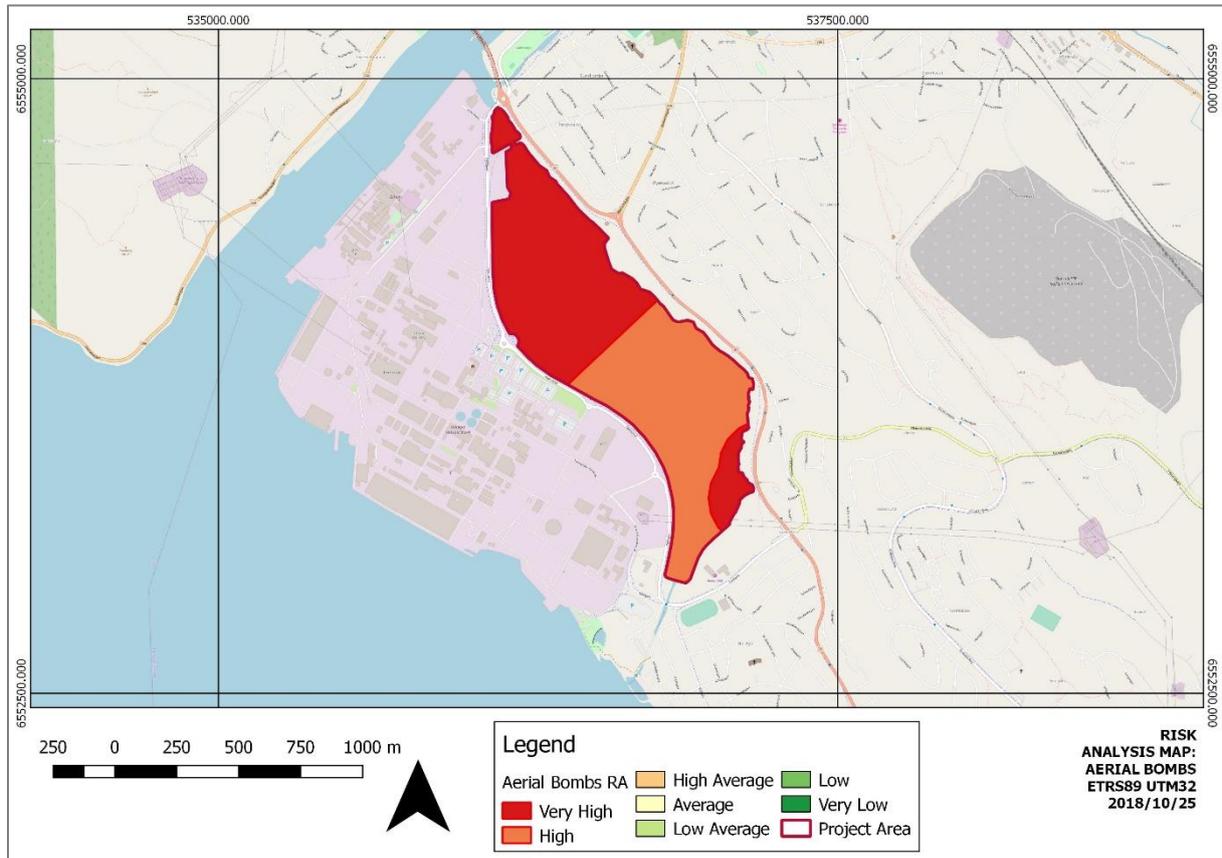
Very High RA in north of project area as well as one small area in south, High RA over rest of project area

Figure 37: Risk Analysis map showing risk attribution for aerial bombs in the project area (ADEDE)

There are several references and sources with detailed descriptions of aerial bombings on or in the vicinity of the project area during the Second World War. The attack on 24 July alone, as stated in the interpretation reports from the USAAF, accounted for 1657 X 500GP of explosive tonnage.⁶⁶ The report issued by *Eidanger Salpeterfabriker* gives an estimate of between 1000 and 1500 aerial bombs dropped.⁶⁷ This number can be assumed to be too low, as the report used lists of reported bomb craters to achieve estimates: locating bomb craters in water can only be done on impact or in very shallow water. Also to be taken into account is the landslide which occurred in the southern part of the Gunneklevfjord, possibility depositing UXO directly into the proposed project area.

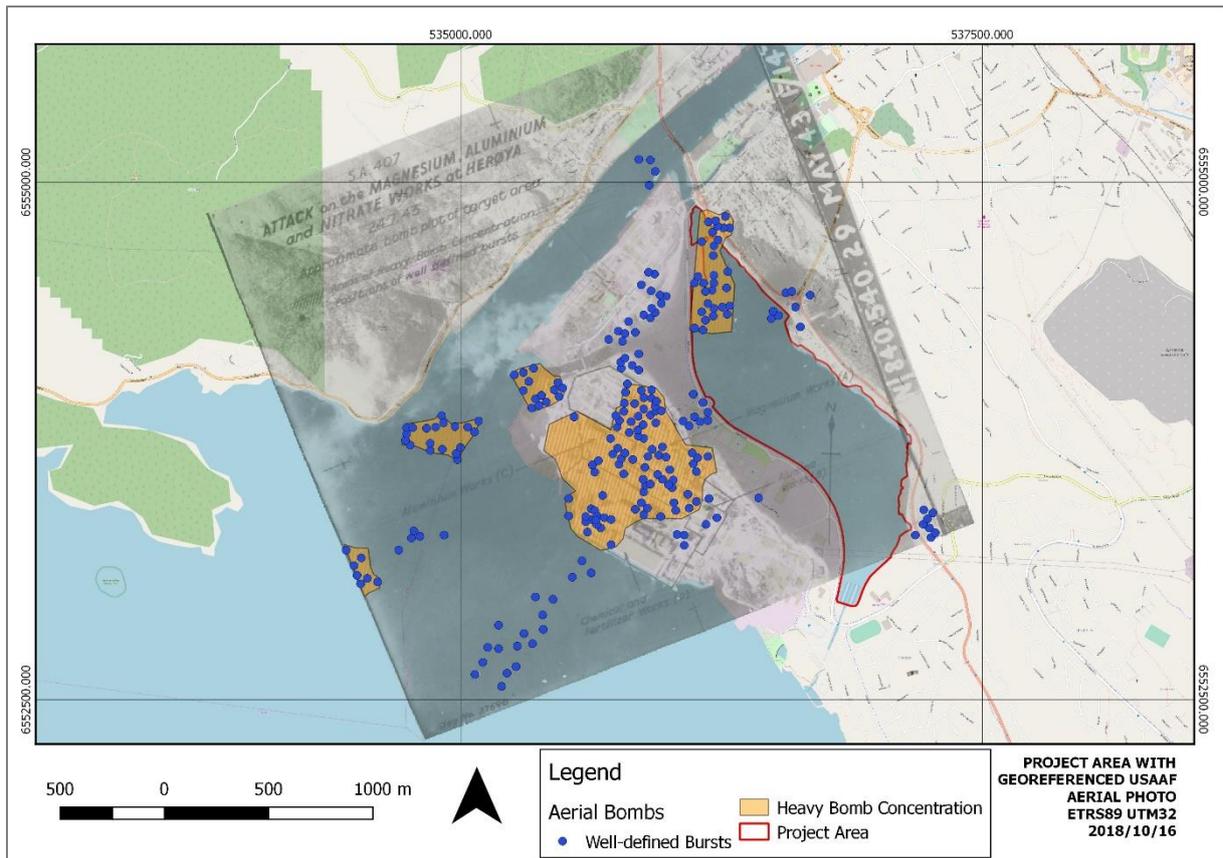
Figure 38: Georeferenced aerial photo of plotted bomb bursts and concentrations. USAAF and ADEDE

Due to the very high likelihood of encountering unexploded aerial bombs, the project area of the Gunneklevfjord was split into three separate risk zones: Very High risk was attributed to the northern part of the body of water; Very High risk was also attributed to a smaller area in the south, in proximity to the recorded landslide; and a High risk attribution was assigned to the rest of the project area.

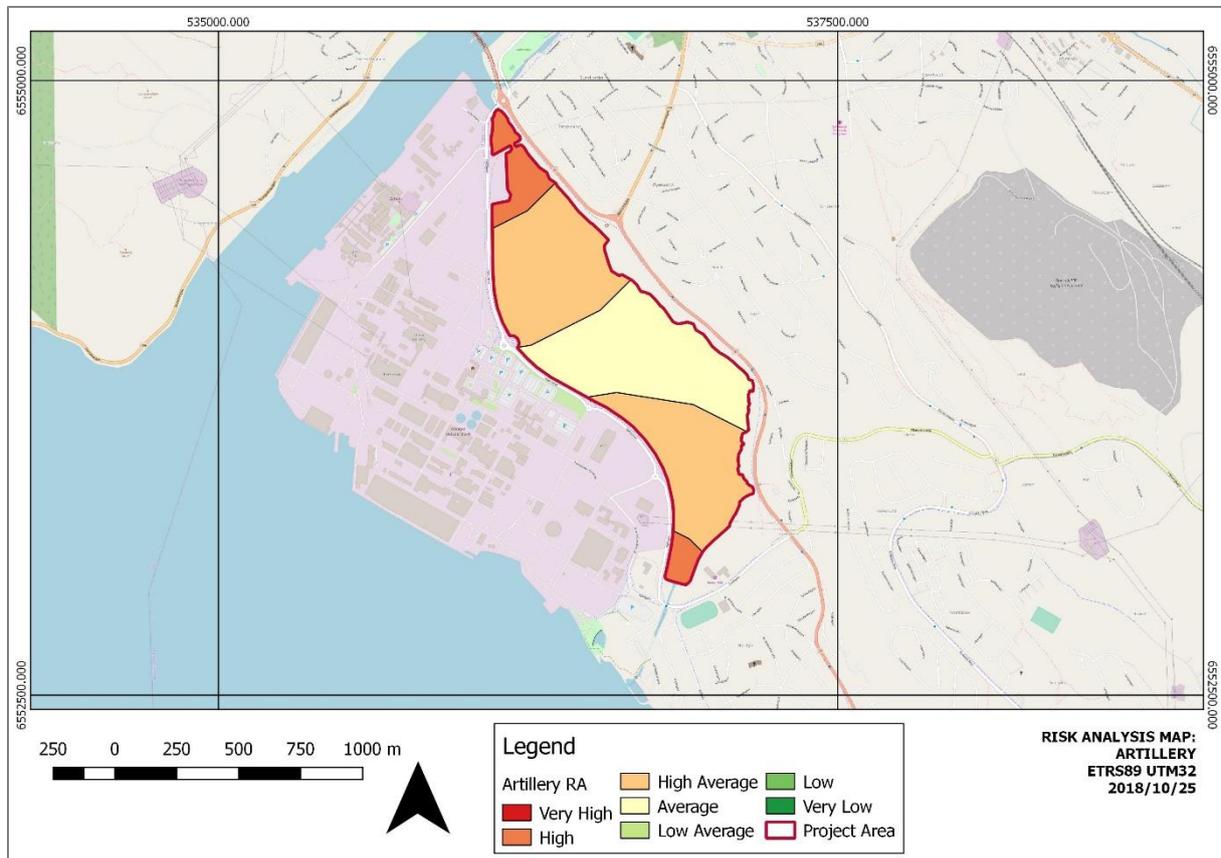
High RA within buffer areas of 500m from former anti-aircraft locations, High Average RA within buffer areas of 1000m from former anti-aircraft locations, and Average RA over rest of project area.

Figure 39: Risk Analysis map showing risk attribution for artillery in the project area (ADEDE)

Before the 24 July attack on Herøya, Germans built anti-aircraft batteries in five different locations in the vicinity of the Gunneklevfjord⁶⁸, two of which were located on the Herøya peninsula, one at Hydros Kasino and one at Roligheten. Buffers of 500m and 1000m were created around these two locations, and parts of these areas fall within the project area of the Gunneklevfjord. Different levels of risk attributions were assigned to these buffer areas.

The buffer of 500m from the anti-aircraft locations was given a risk attribution of High, while the larger buffer of 1000m was given a risk attribution of High Average. The part of the project area which the buffers did not cover was given a risk attribution of Average.

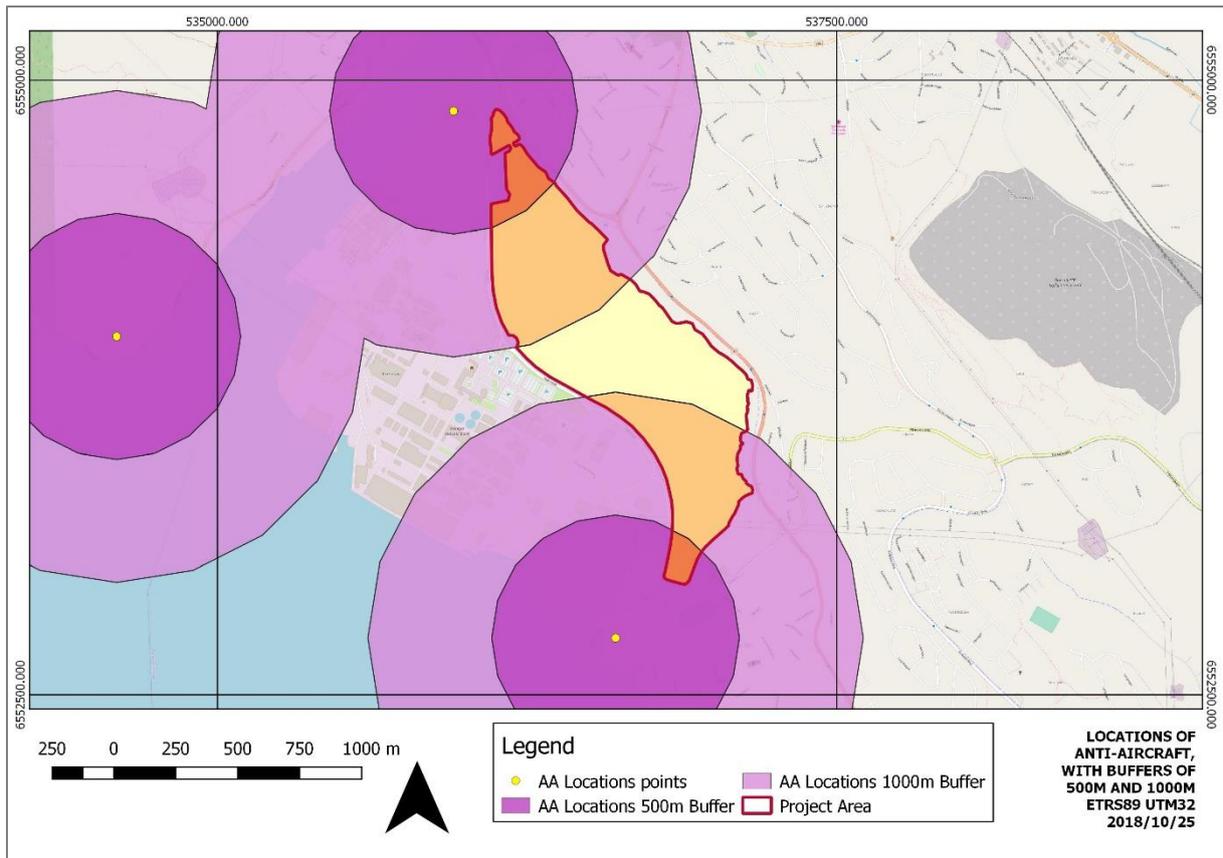
Figure 41: Map showing anti-aircraft locations with buffers of 500m and 1000m. (ADEDE)

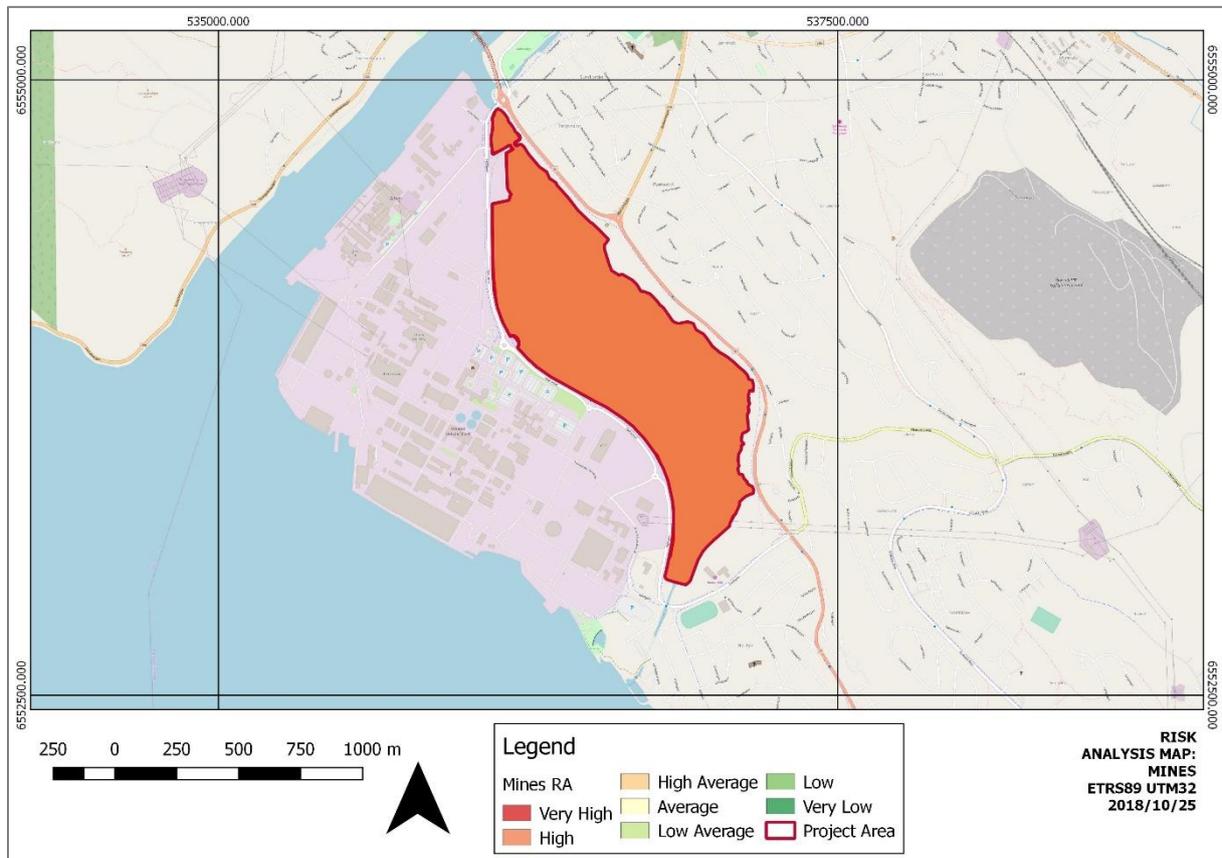
High RA over project area

Figure 42: Risk Analysis map showing risk attribution for mines in the project area (ADEDE)

Not only was Porsgrunn assigned a unique target codename (Polyanthus VI) for identification in the Allies' "gardening" operations, but three logged missions of minelaying in the vicinity are relevant to the project area.
