Herøya Industripark - Porsgrunn

Historical Research on the Possible Presence of Unexploded Ordnance

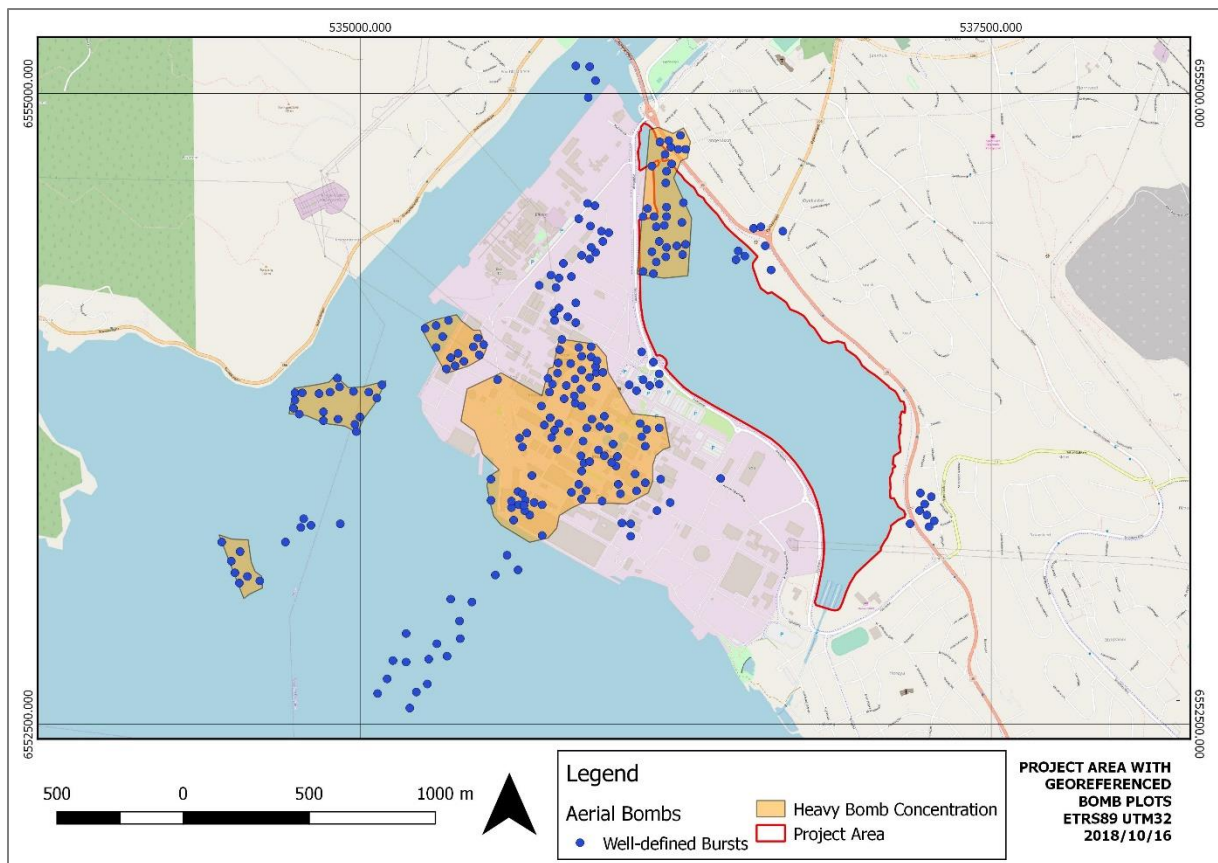
Figure 8: Project area with bomb plots (well-defined bursts and heavy bomb concentration) from Figure 5. Note the amount of bombs inside project area. (ADEDE and USAAF Interpretation Report)

The aerial photo from the USAAF Interpretation Report No. SA-407 (shown in Figure 6) was georeferenced and then superimposed over a current map of the project area. The bomb bursts and areas of heavy concentration were traced over so as to be easier to read (see Figures 7 and 8). If the blue dots (each showing a “well-defined burst”) in the Gunneklevfjord are counted, then a total of 25 well-defined bursts landed in the fjord itself. Even if each blue dot would only represent a single bomb, that would add to a total 12,500 pounds of explosives (each bomb being 500 lbs). However, that is not taking into account the fact that the Gunneklevfjord used to be larger (see Figures 9 and 10 for comparison). The peninsula was expanded in the meanwhile since WWII. Observing the aerial photo from Figure 6, and counting the number of dots that fall into the former fjord, the number rises from 25 to 42. If each dot is still only one bomb, that would amount to 21,000 pounds of explosives (see Figure 10).

other. The northern area of the Gunnekelevfjord, between the high concentrations of bomb bursts, can be attributed with a high expectation of unexploded aerial bombs.

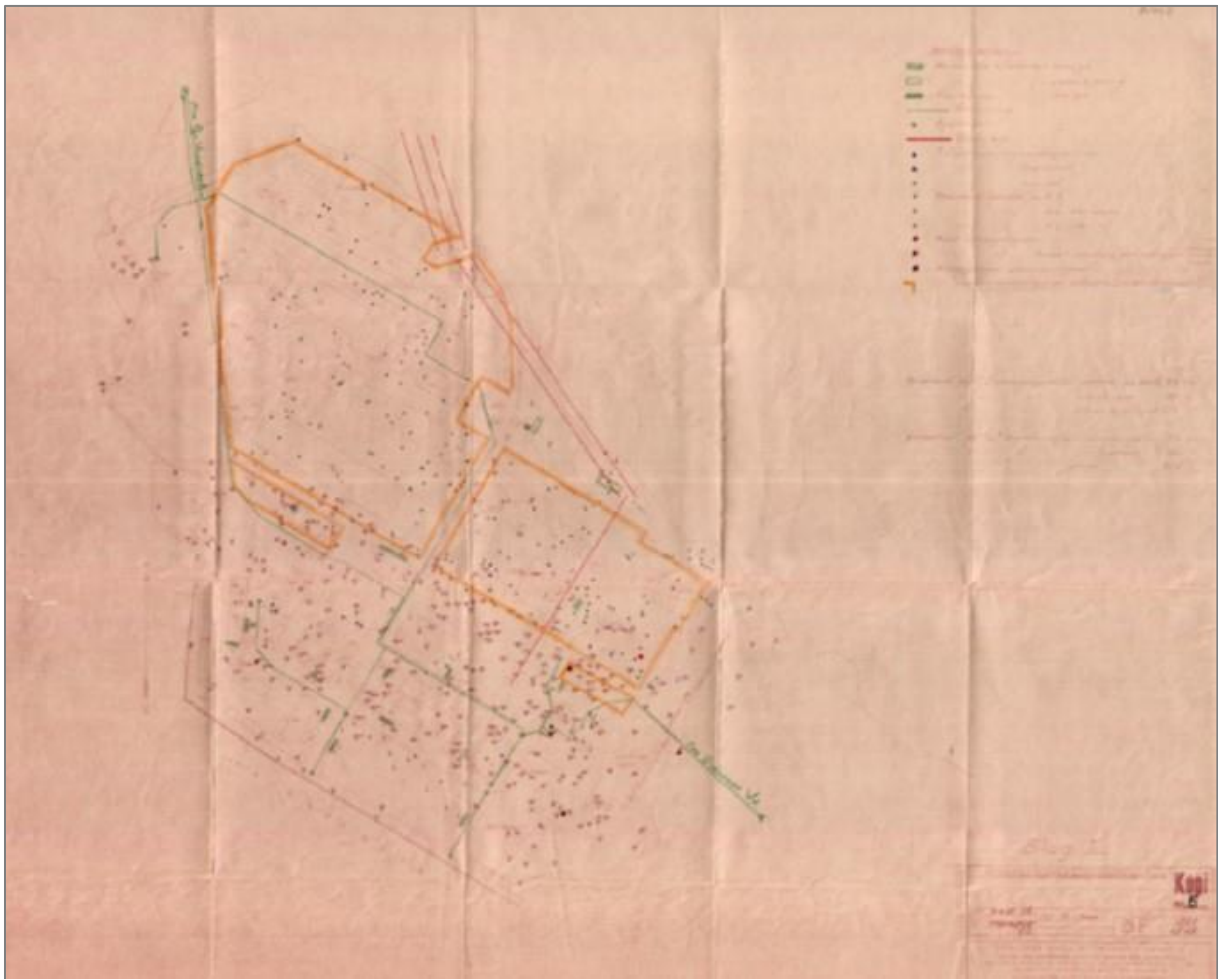
Figure 14: Map from report issued by Eidanger Salpeterfabrik, showing recorded locations of bomb hits and UXO

The pink map shown in Figure 14 depicts the peninsula of Herøya with “bombtreff” (bomb hits) plotted. Figure 15 is a detail from the map legend of Figure 14. The legend lists bomb hits on Eidanger Salpeterfabrik (“E.S.”) as well as Norsk Lettmetall (“N.L.”), and lists bomb hits found in buildings (“i bygninger”) and outside of buildings (“utenom bygninger”). Tallying these numbers, the report states that at least 580 bombs fell on these two factories.

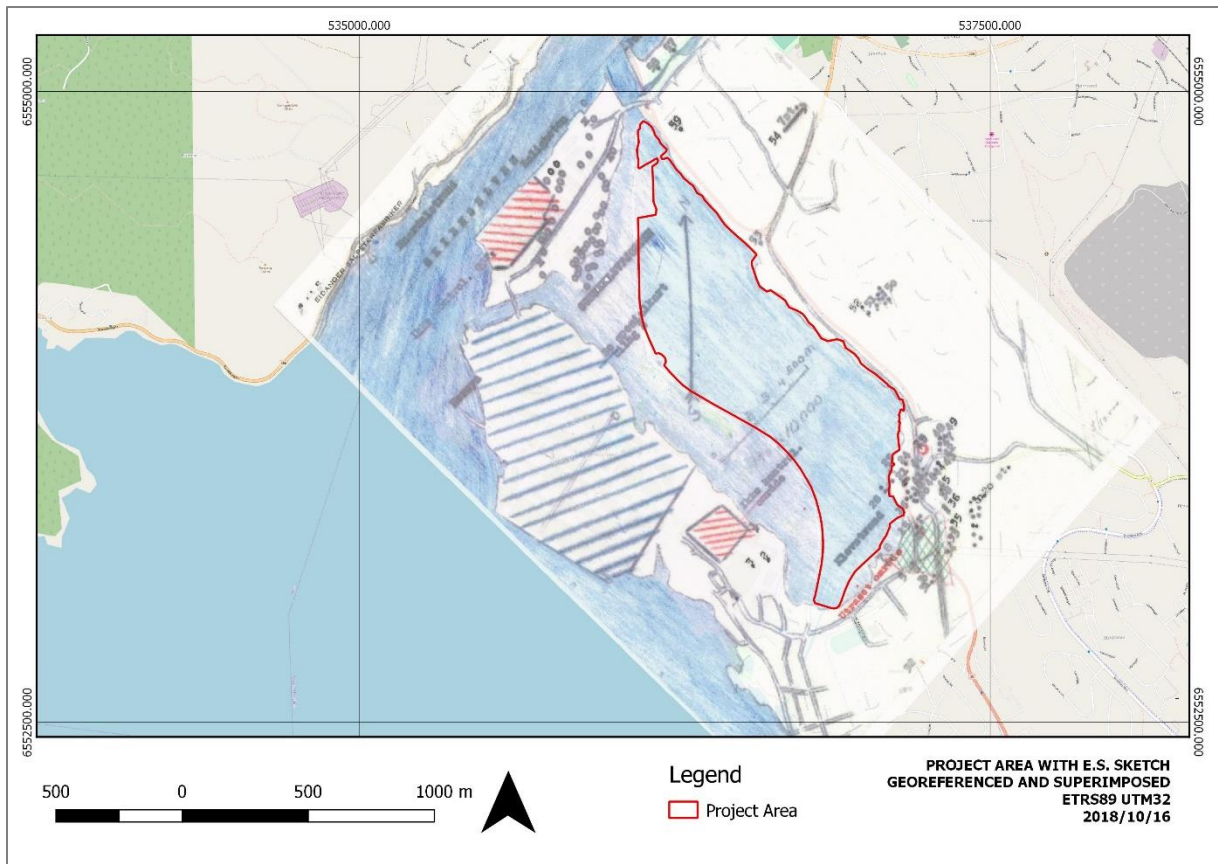
Figure 19: Sketch from Figure 18 georeferenced and superimposed over project area. (*ADEDE and Eidanger Salpeterfabrik*)

It can be concluded that there exists the possibility of UXO having ended up in the southern part of the Gunneklevfjord. More than one source refers to the considerable landslide, a landslide directly caused by the bombing of 24 July 1943. Since no methodical clearance of the Gunneklevfjord has yet been performed, the risk of encountering unexploded ordnance in the fjord is high.

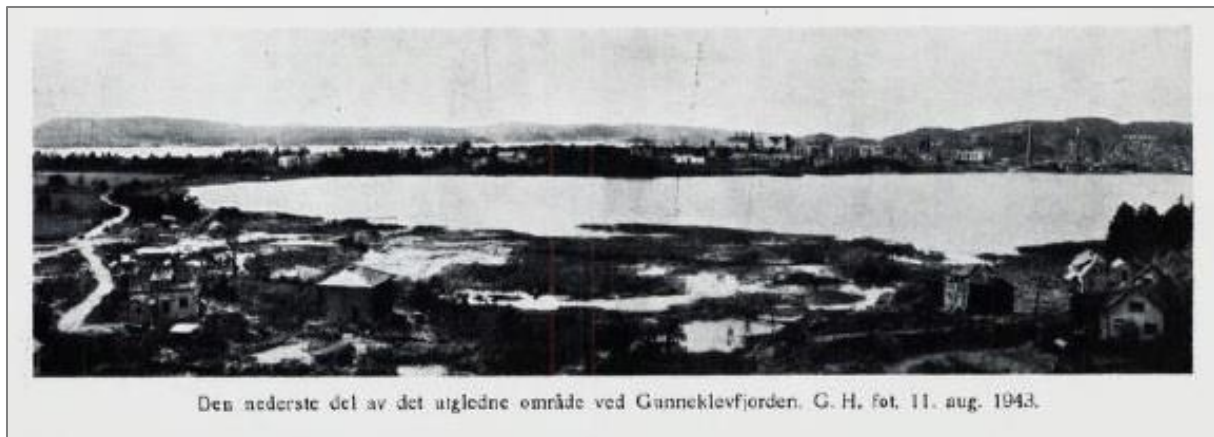
One specific consequence of the 24 July attack was a landslide on the southern shoreline of the Gunneklevfjord. During the attack, a number of bombs were dropped on the southern end of the fjord where homes had been constructed on clay. The impact of the bombings began to cause soil liquefaction, thus prompting a landslide of soil, house rubble, and possible UXOs into the fjord itself.

Figure 21: Photo of Gunneklevfjord after the landslide (11 August 1943). Caption reads: "The lowermost area of the landslide at Gunneklevfjorden"²⁹

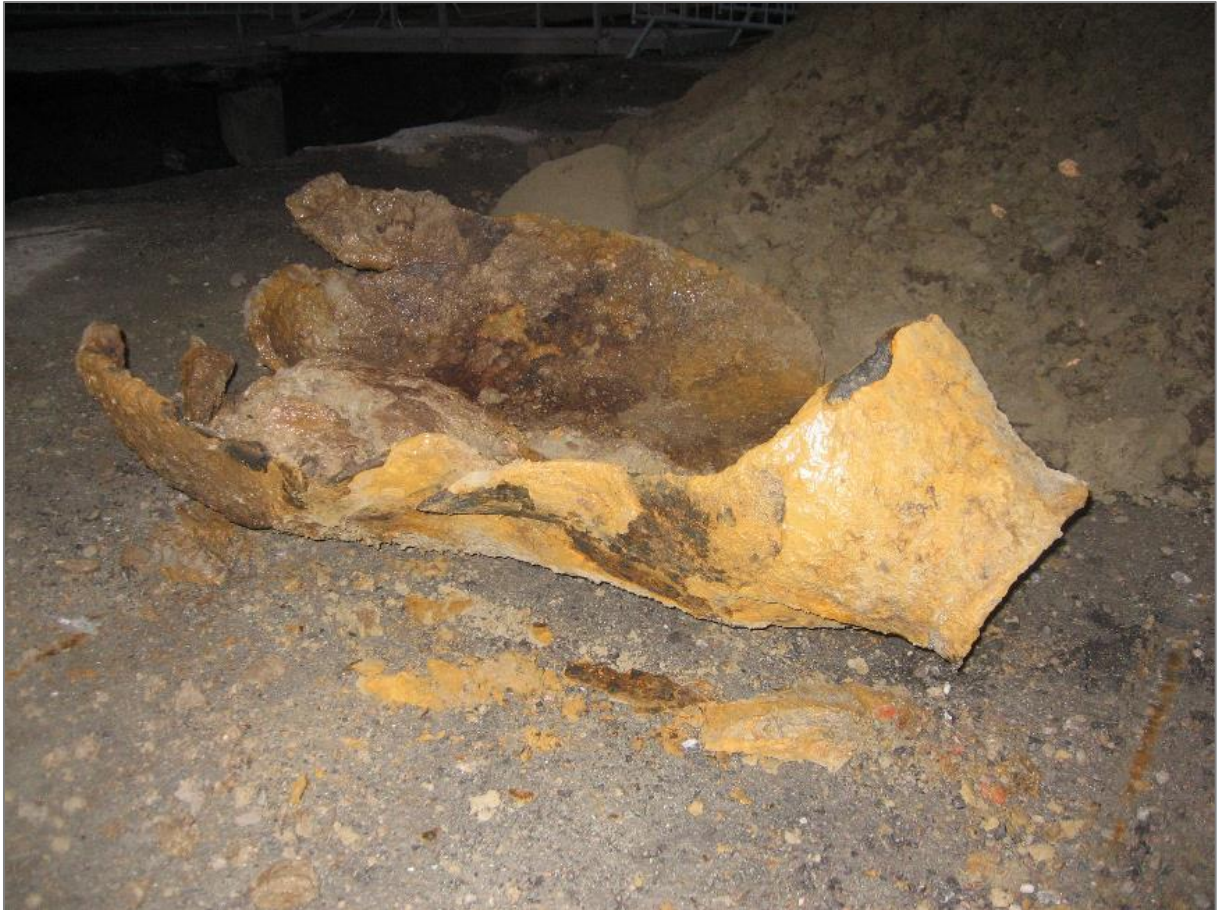
- On the 4th of January 2013 parts of a (detonated) bomb were discovered when digging at “crossroad C/20” (see Figures 33, 34 and 35). This confirms that the position of “crater 103”, as described in the report released by *Eidanger Salpeterfabriker* is fairly accurate.
- On the 25th of July, 1943, German AA projectile splints were recovered from a beach (Figure 35).
- On the 14th of September 1982 an Impeller from the fuse of a US bomb was found.
- In 1982/83, the industrial park reported the discovery of parts of US 500 lb bomb, as well as splints. These were found in a storage at Herøya during a clean-up.

Figure 34: Photo of a detonated bomb recovered at Herøya. The bomb resembles a US M43 500lb bomb.⁶³

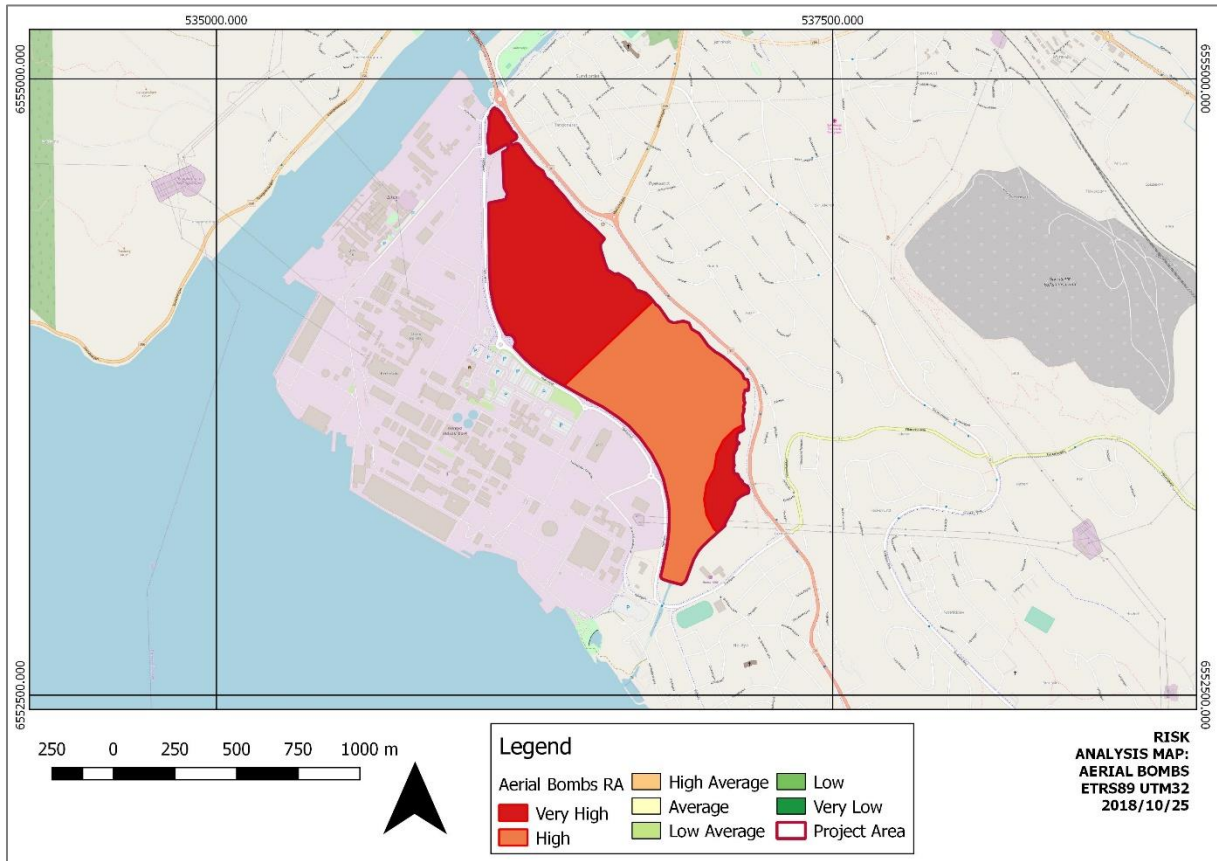
Very High RA in north of project area as well as one small area in south, High RA over rest of project area

Figure 37: Risk Analysis map showing risk attribution for aerial bombs in the project area (ADEDE)

Due to the very high likelihood of encountering unexploded aerial bombs, the project area of the Gunneklevfjord was split into three separate risk zones: Very High risk was attributed to the northern part of the body of water; Very High risk was also attributed to a smaller area in the south, in proximity to the recorded landslide; and a High risk attribution was assigned to the rest of the project area.

Based on the historical evidence, it is highly recommended to take further safety steps in order to secure any works in the proposed project area of the Gunneklevfjord. There exists the possibility of unexploded ordnance within the proposed project area, both on land as well as on the seafloor, and, when detected, they should be safely removed.

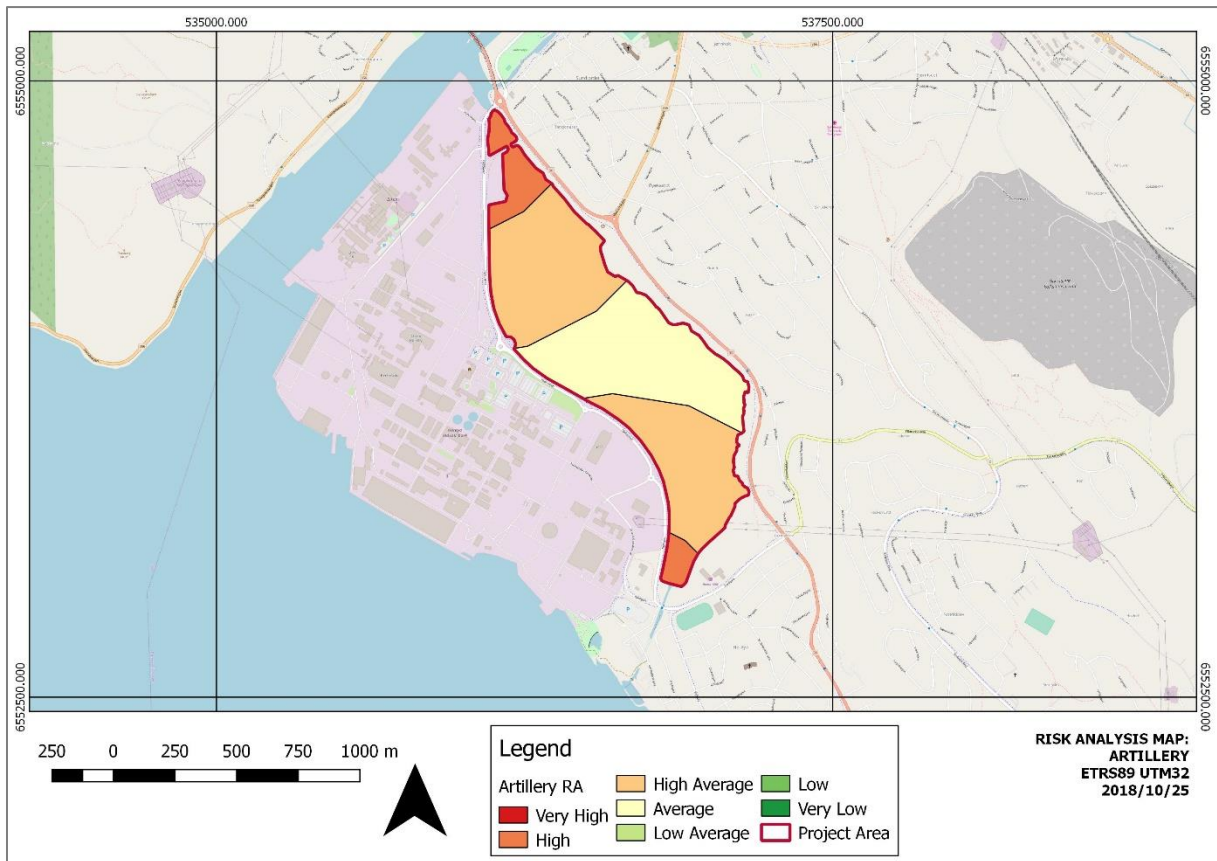
High RA within buffer areas of 500m from former anti-aircraft locations, High Average RA within buffer areas of 1000m from former anti-aircraft locations, and Average RA over rest of project area.

Figure 39: Risk Analysis map showing risk attribution for artillery in the project area (ADEDE)

The buffer of 500m from the anti-aircraft locations was given a risk attribution of High, while the larger buffer of 1000m was given a risk attribution of High Average. The part of the project area which the buffers did not cover was given a risk attribution of Average.

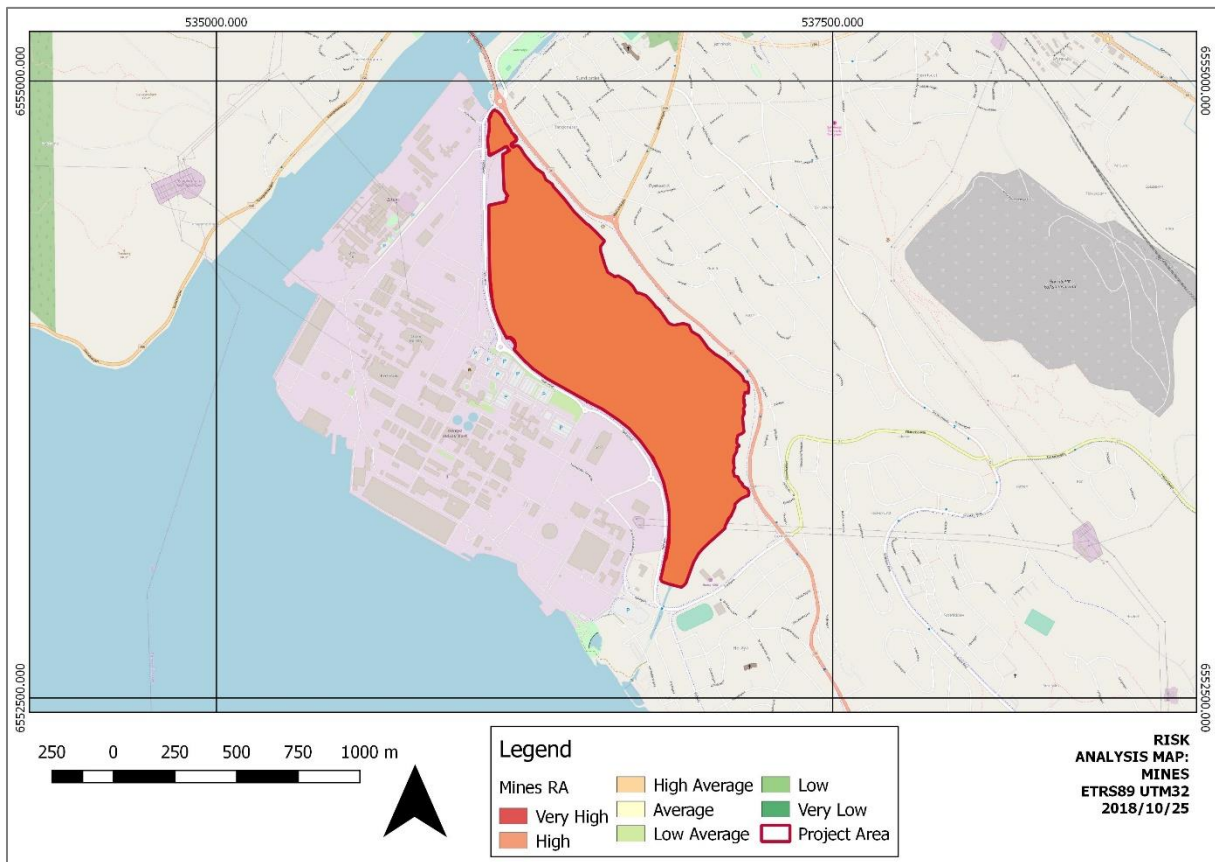
High RA over project area

Figure 42: Risk Analysis map showing risk attribution for mines in the project area (ADEDE)
