HISTORICAL UXO RESEARCH Nedre Frednes in Porsgrunn (Norway)

ADEDE RESEARCH REPORT 740 – 2021

Client: Porsgrunn Kommune

Date: 13th of August 2021

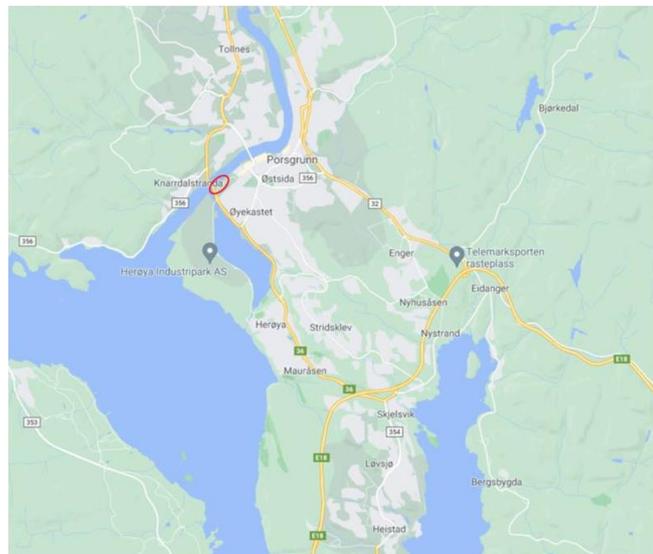
fig. 1: Location of the planned project within the municipality of Porsgrunn.

The project area is situated at Frednes, which is a part of the Norwegian municipality Porsgrunn (see fig. 1-3). The client plans in the project area a combination of apartment buildings with underground parking, office areas, stores, a park etc. (see fig. 4).

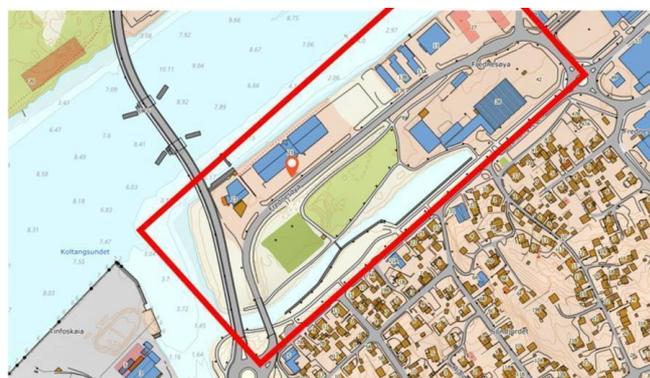
fig. 2: An overview of the current state of the project area.

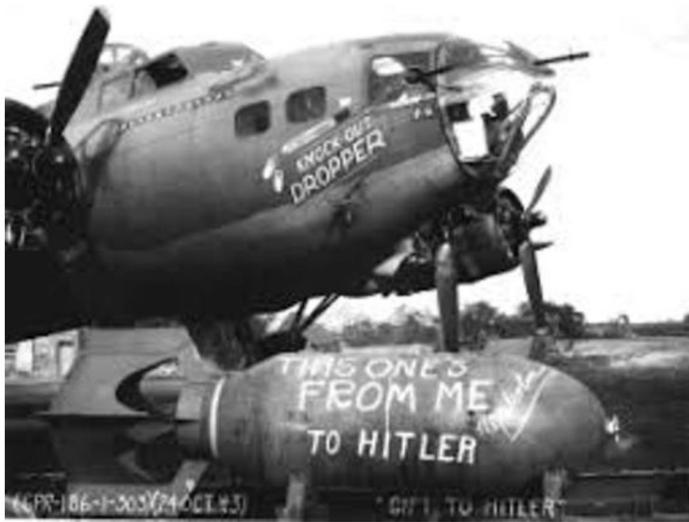
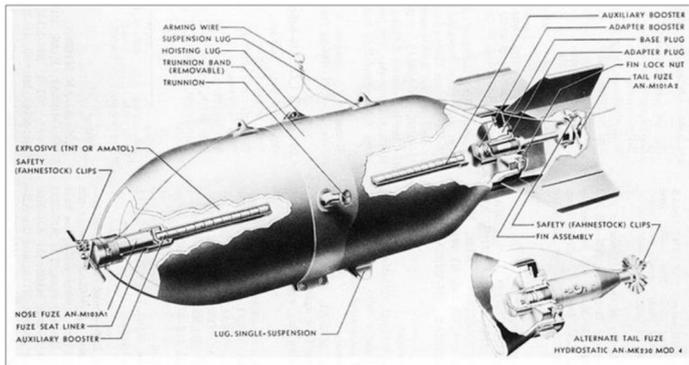
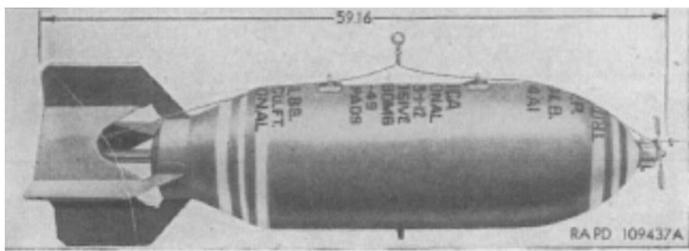
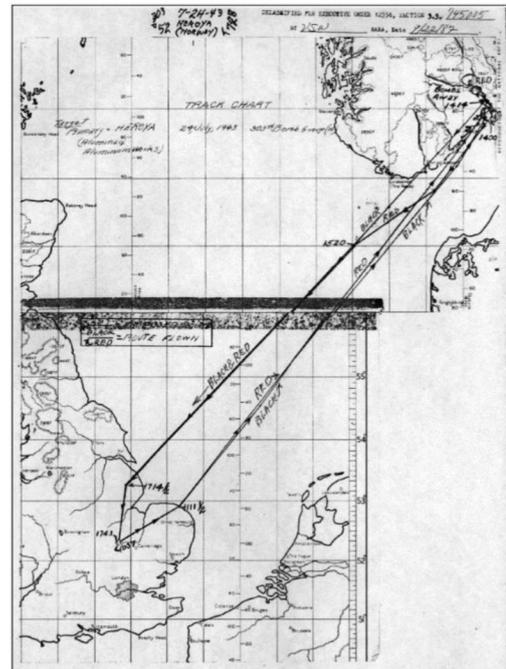
fig. 5: On the left: Each bomber carried ten high explosive M43 bombs of 500 lbs.³
 On the right: Route map of the USAAF bombardment mission to Herøya, 24 July 1943.

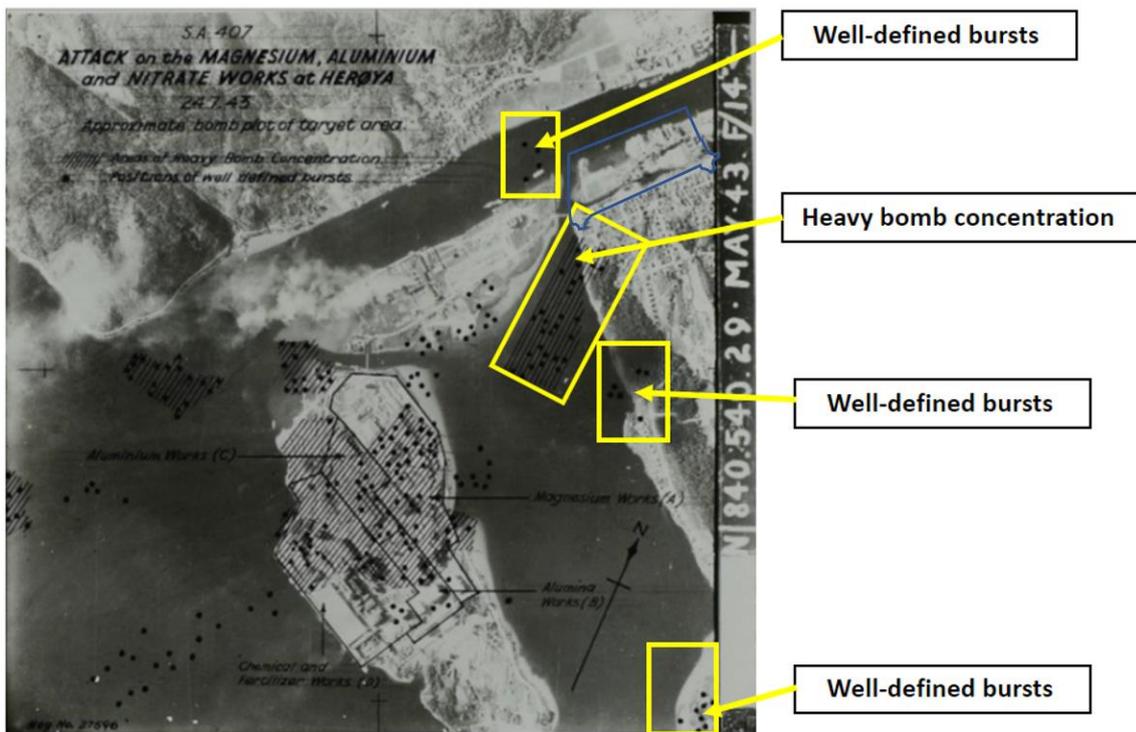
fig. 6: Approximate bomb plot at the northeast and southeast banks of Gunneklev Fjord.⁴

Despite the German air defence, several B-17s and 1 YB-40 managed to cross Gunneklev Fjord, from the northeast to the southwest. On Herøya, they bombed the magnesium, alumina, aluminium, and nitrate plants of A/S Nordisk Lettmetal, which were considered essential to the German war effort. The plants were just completed as the bombs began to drop.⁵ Both Gunneklev Fjord and Herøya Peninsula were severely hit. On and near the northeast, the east and southeast banks of Gunneklev Fjord, which were wooded and sparsely settled, a concentration of respectively 39, 11 and about 40 bursts could be observed (see fig. 7 and 8).

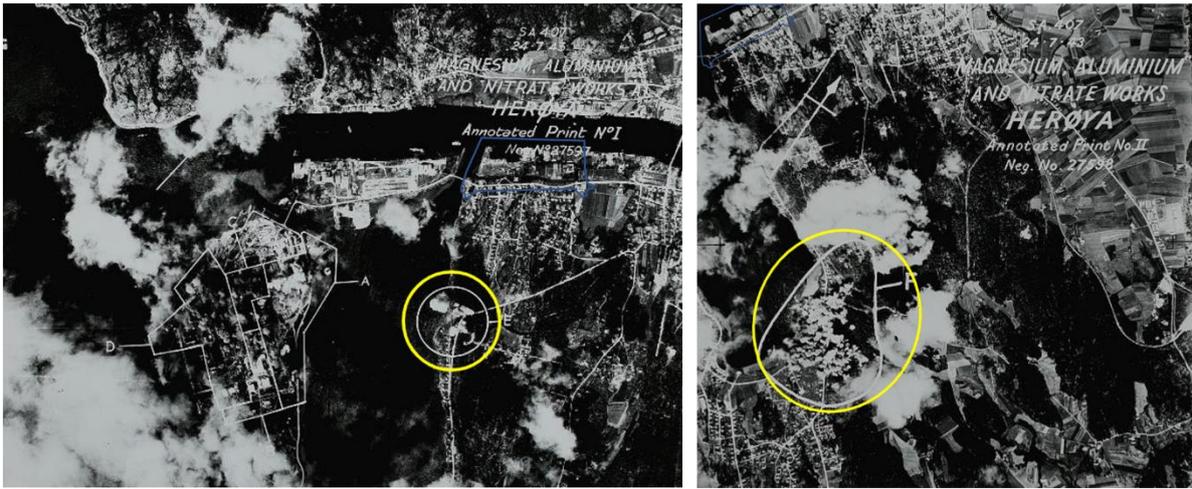
fig. 7: On the left: Bombing of the northeast bank of Gunneklev Fjord.⁶
 On the right: Bombing of the east and southeast bank of Gunneklev Fjord.⁷

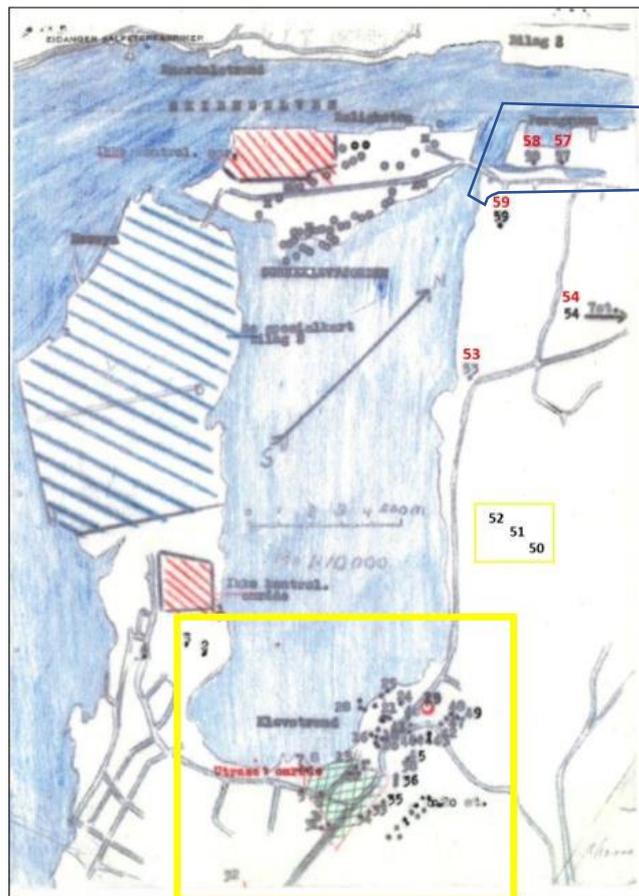
fig. 8: Approximate bomb plot at the east of Gunneklev Fjord.⁸

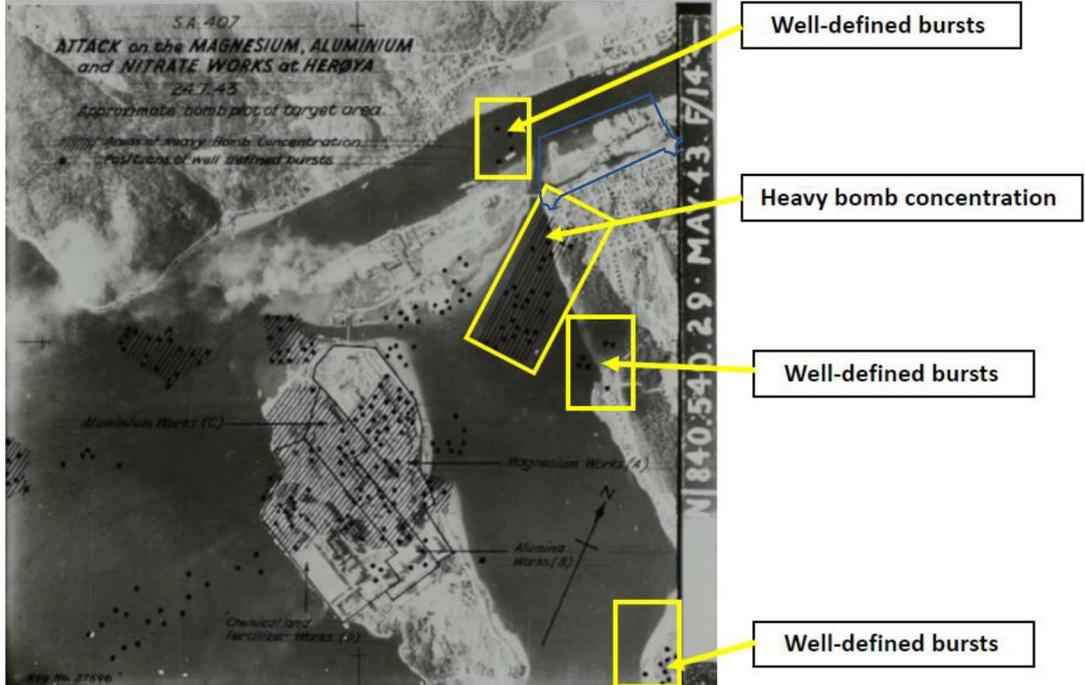
fig. 9: Approximate bomb plot at the northeast and southeast banks of Gunneklev Fjord.¹⁰

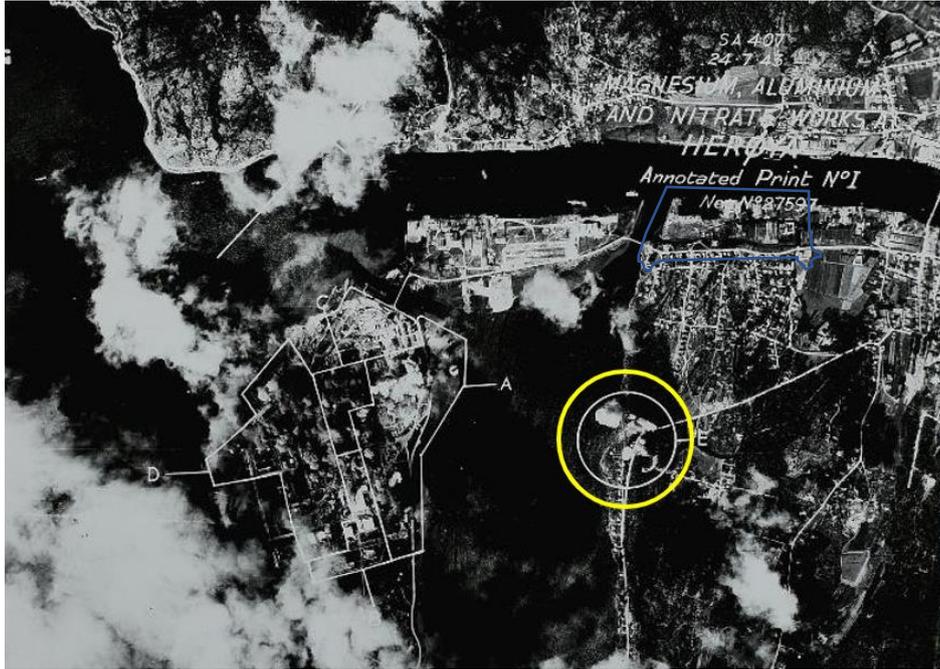
fig. 10: Bombing of the northeast bank of Gunneklev Fjord.¹¹

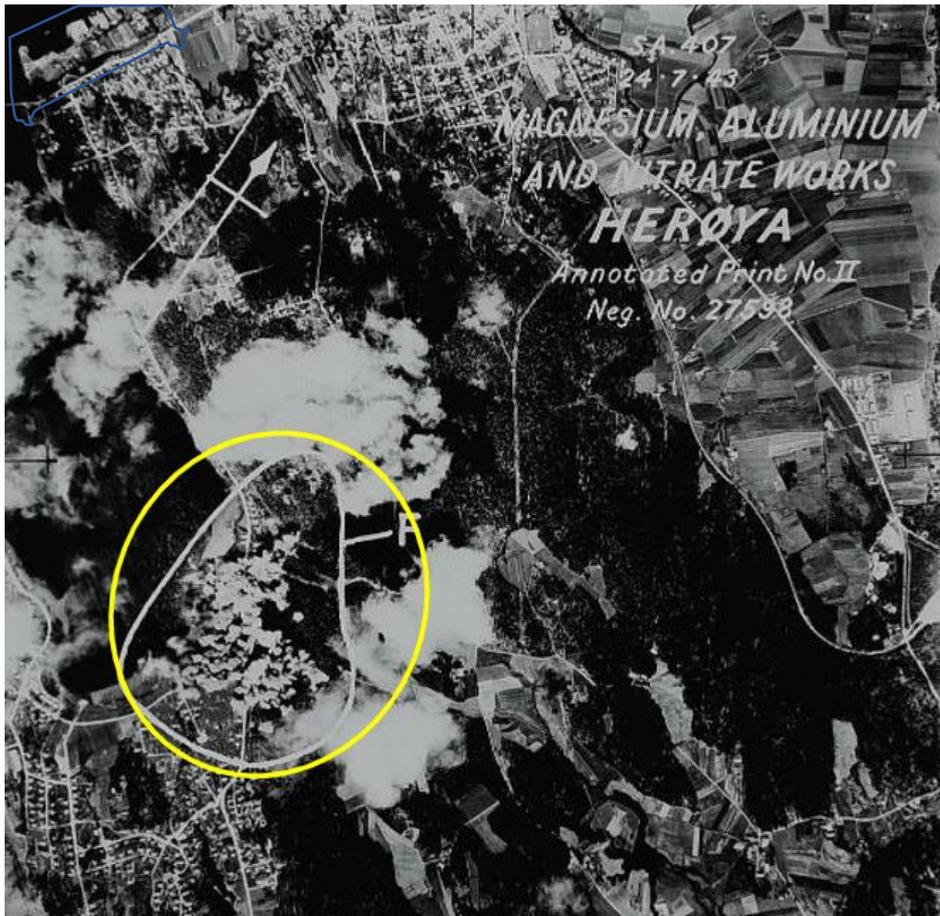
fig. 11: Bombing of the east and southeast bank of Gunneklev Fjord.¹²

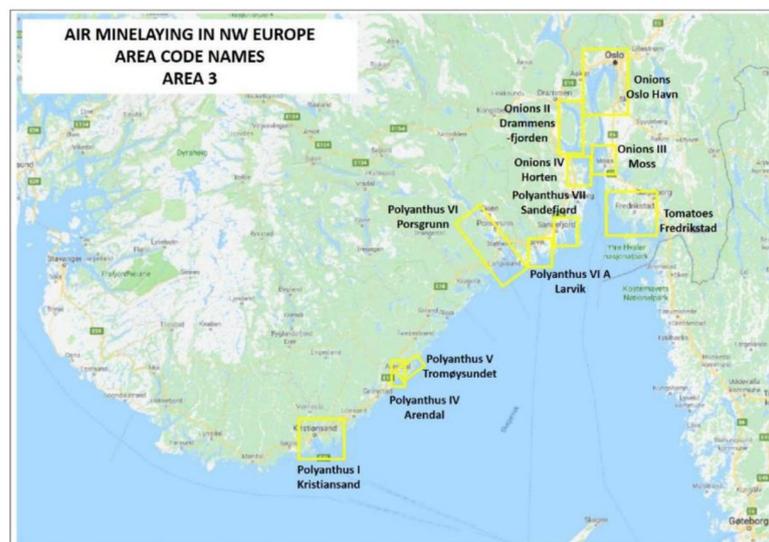
fig. 12: The subareas of area 3, in which the Gardening Operations of the RAF Bomber Command took place.¹³

The so-called Gardening Operations of the British Royal Air Force (RAF) Bomber Command implied the dropping of mines from bomber aircraft into the sea. The mines were “sown” near ports and harbours, inland waterways, estuaries, and busy shipping lanes. To this end, the coastline throughout Europe was divided into areas and subareas, which were given distinct code names, mostly after trees and plants. Area 3, which took in the south coast of Norway from Kristiansand eastwards to Oslo, contained several ports of varying capacity. Porsgrunn was part of area 3 and subarea “Polyanthus VI” (see fig. 12).

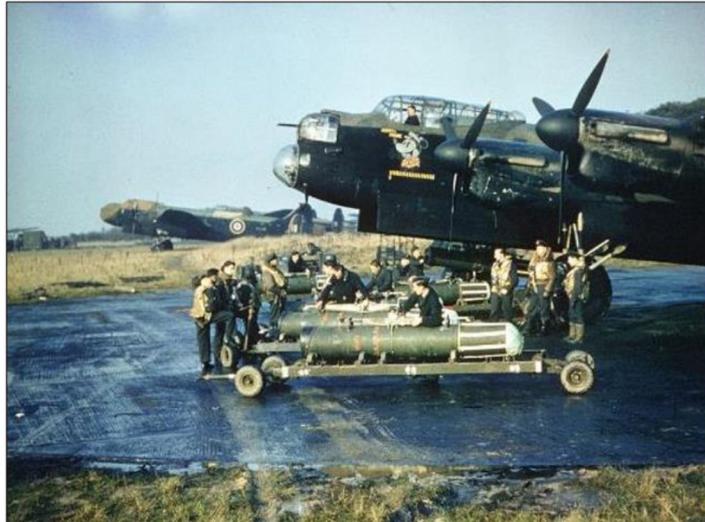
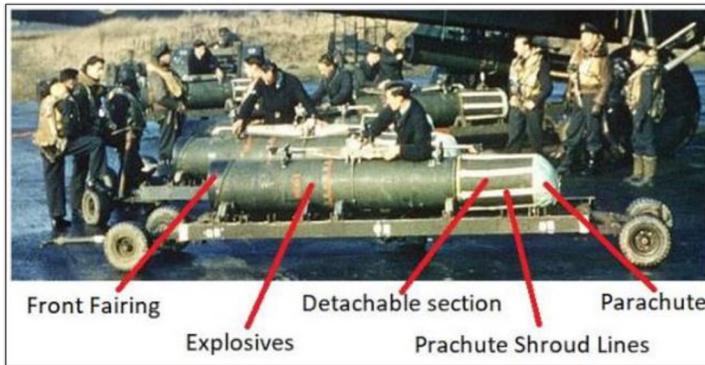
fig. 13: Loading Lancasters with A Mk I-IV and A Mk VI mines of 2000 lbs.

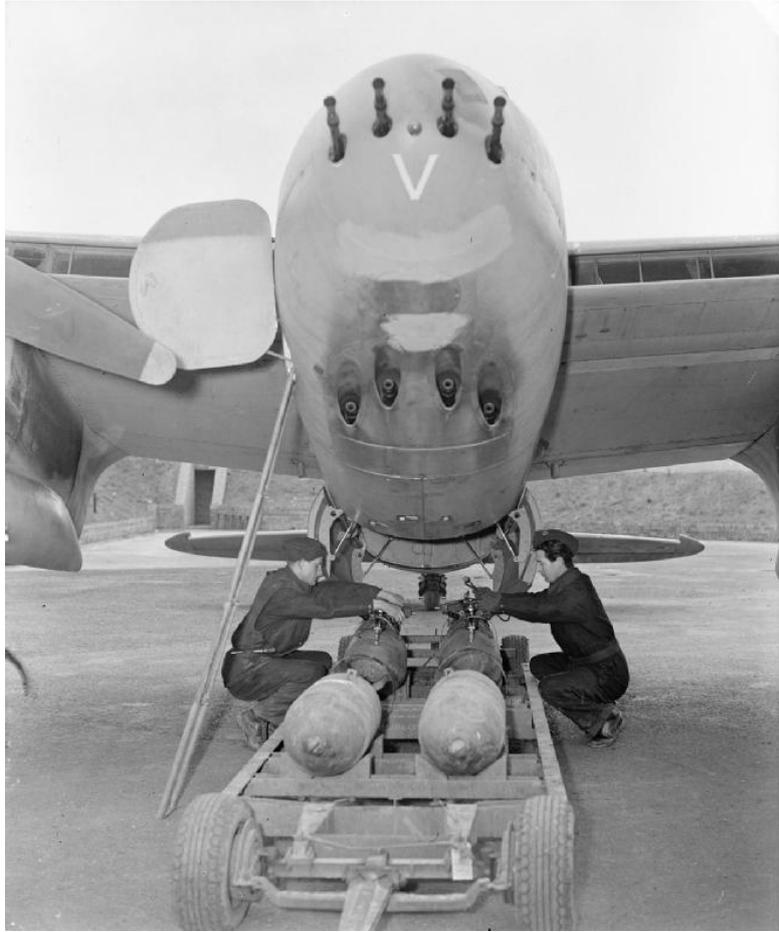
fig. 14: Armourers load four 500 lbs MC bombs into the bomb-bay of a de Havilland DH.98 Mosquito fighter-bomber (FB) Mk VI, 1944. This type of aircraft was armed with four .303 in Browning machine guns and four 20 mm cannons.¹⁷

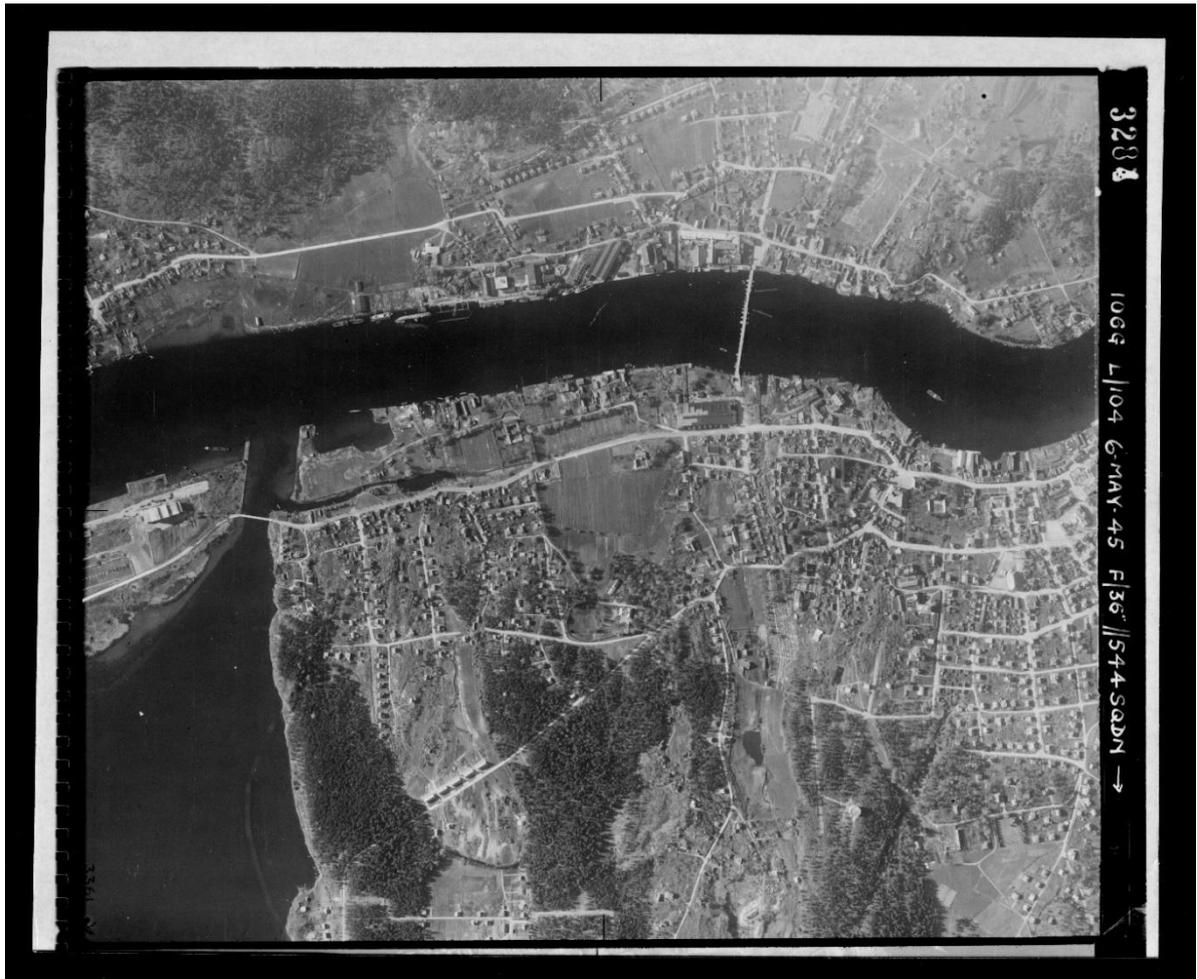
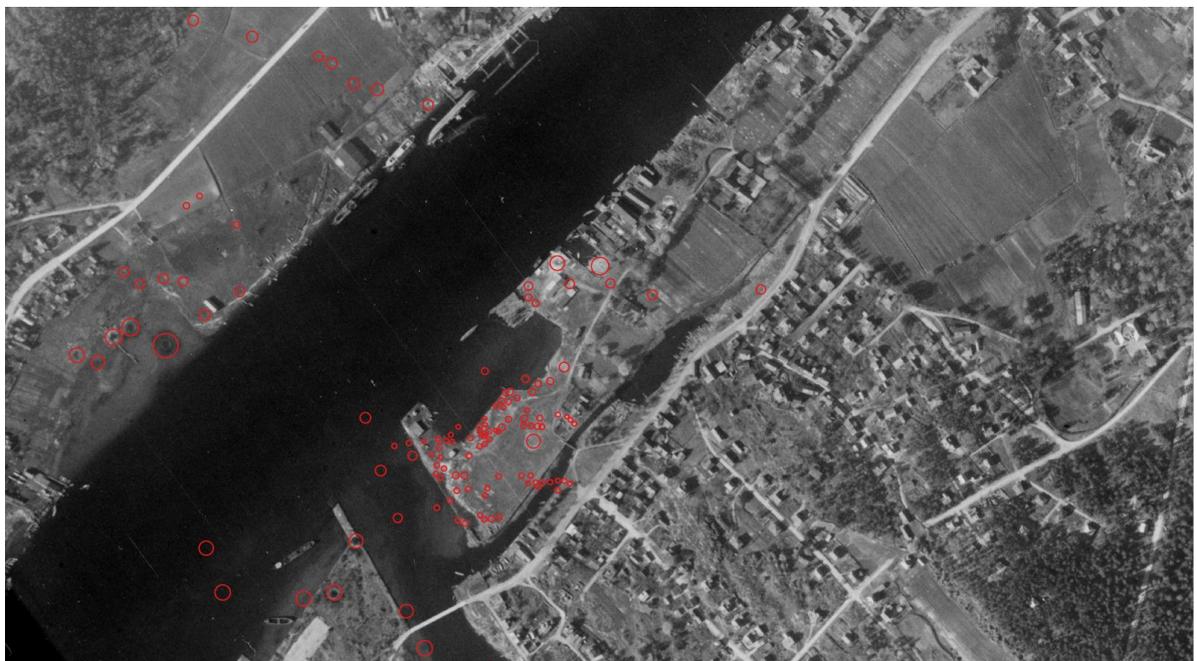
fig. 17: Situation of the project area on a historical aerial photograph of 6 May 1945.¹⁹

Two historical aerial photographs of 6 May 1945 show the traces of the British air raid (see fig. 17 and 18). The photographs are separate frames from the same sortie. Both were necessary for identifying the craters. This was done through QGIS, by georeferencing and comparing them in detail.

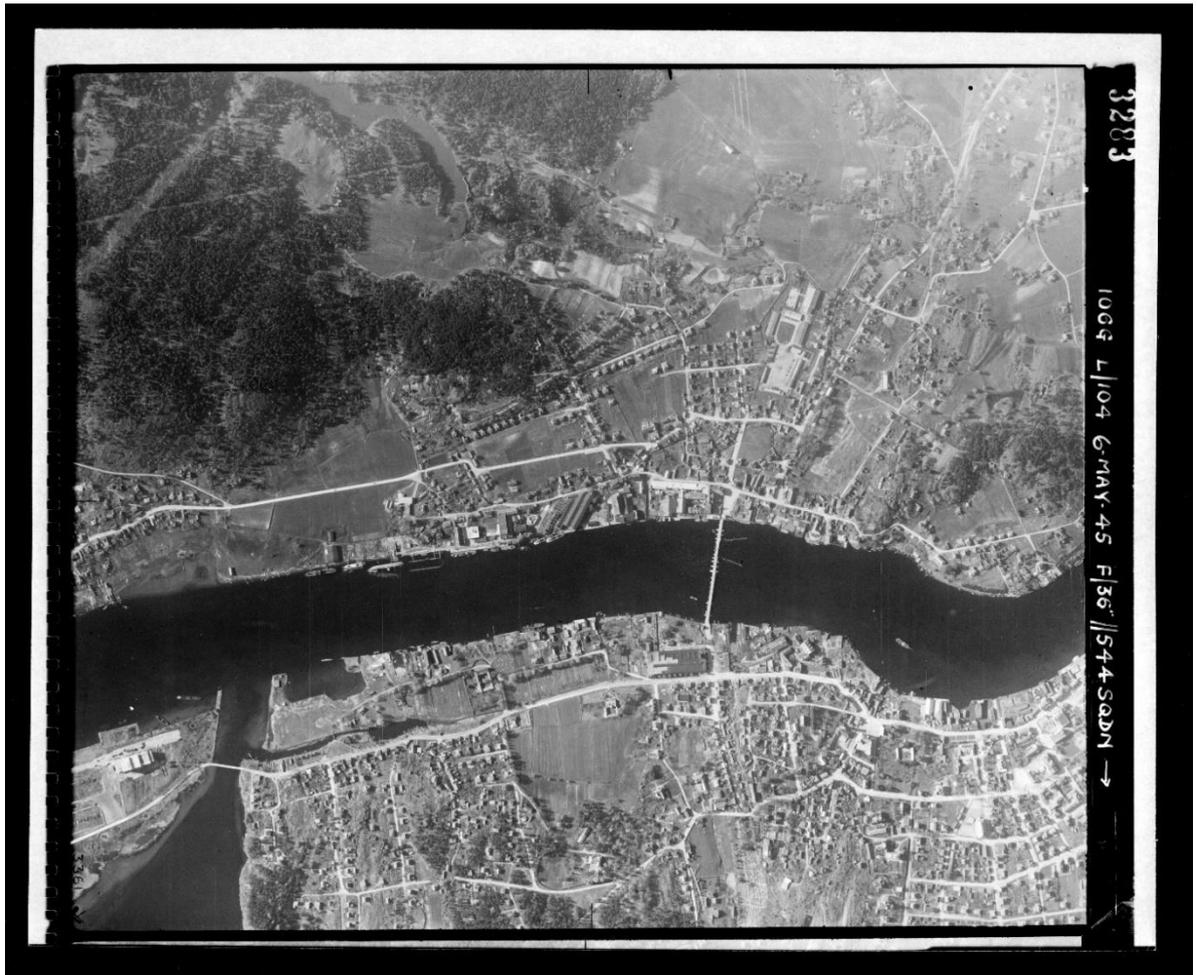
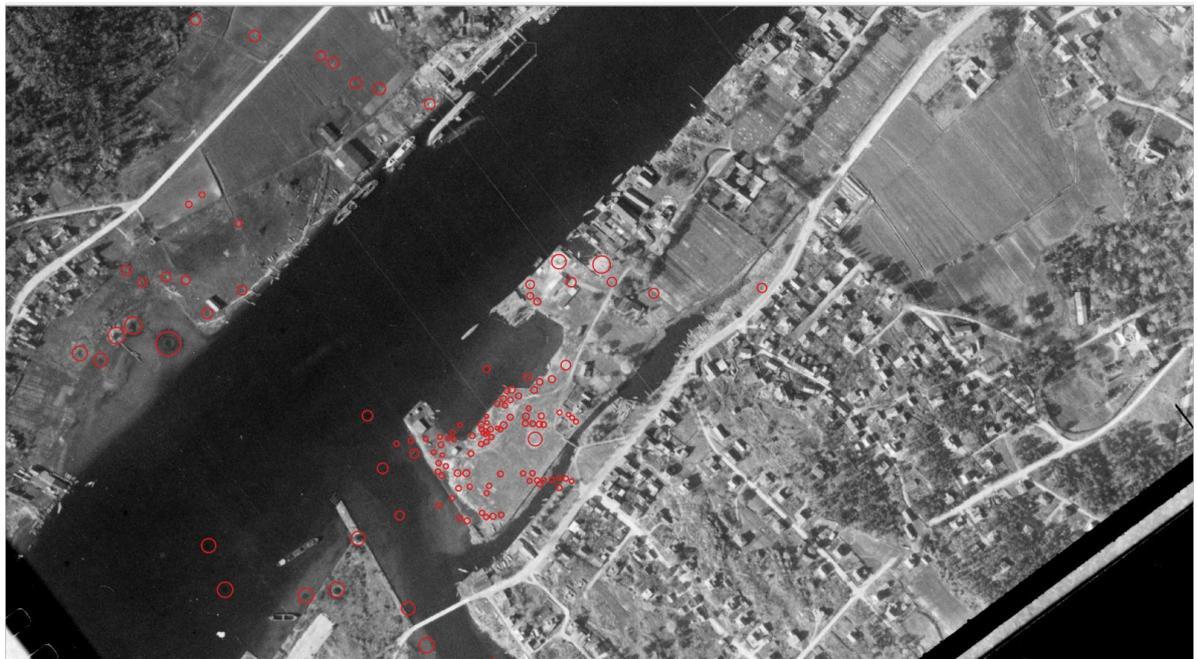
fig. 18: Situation of the project area on a historical aerial photograph of 6 May 1945.²⁰

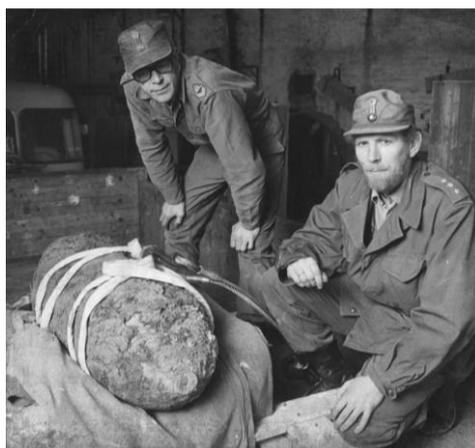
fig. 19: Officers found an aerial bomb in Porsgrunn in 1974.²³

Immediately after July the 24th 1943, a crew from the German Bomb Disposal Command cleared unexploded ordnance within a diameter of 200 m around the impact sites near Porsgrunn. Some bombs were destroyed on site, some were destroyed elsewhere, and some stayed in place, when they had fallen into loose soil and when there was a suspicion that they had time-delay fuses. In that case, a safety period of two years was considered. After this two years period, the bombs were removed. That means that there are no longer bombs with time-delay fuses from the 1943 bombardment in the project area.²¹ During the following years and after the war, probably no other systematic ammunition clearance has been done. In 1974, for example, officers found an aerial bomb in Porsgrunn (see fig. 19).²²

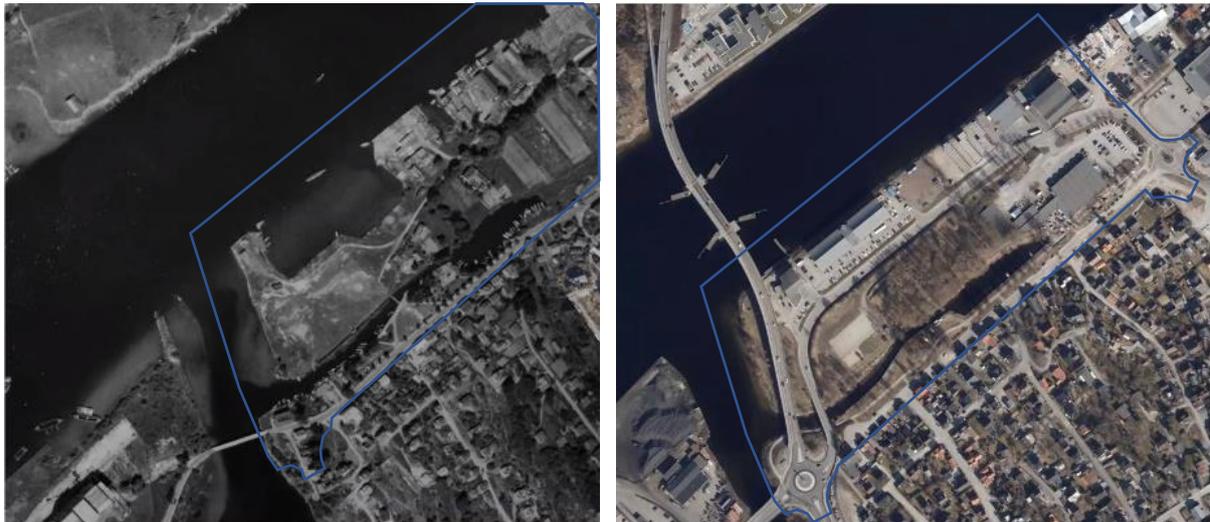
Post-war aerial photographs show that important infrastructure works have taken place in the project area between 1947 and 2019 (see fig. 20). The docks were filled in, the land area was expanded in the southwest, and buildings and roads were constructed. Since the origin of the backfill soil is unknown, it is assumed that the soil may still contain artillery ammunition.

fig. 20: Situation of the project area on aerial photographs of 1947 and 2019.

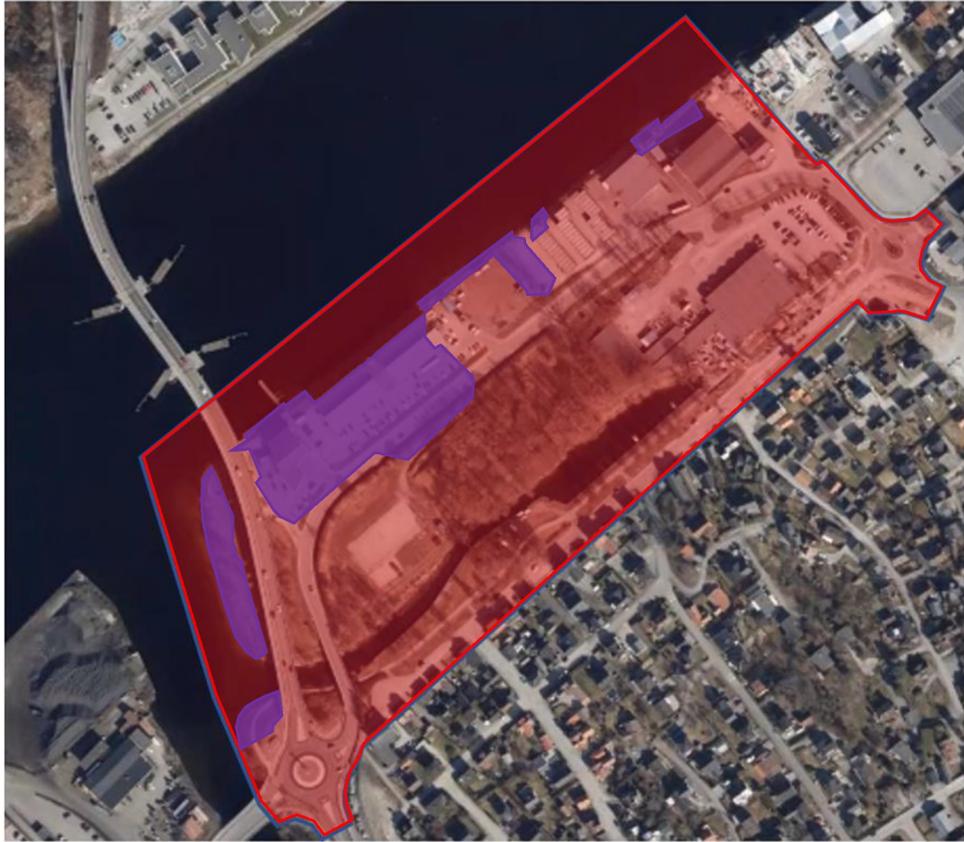
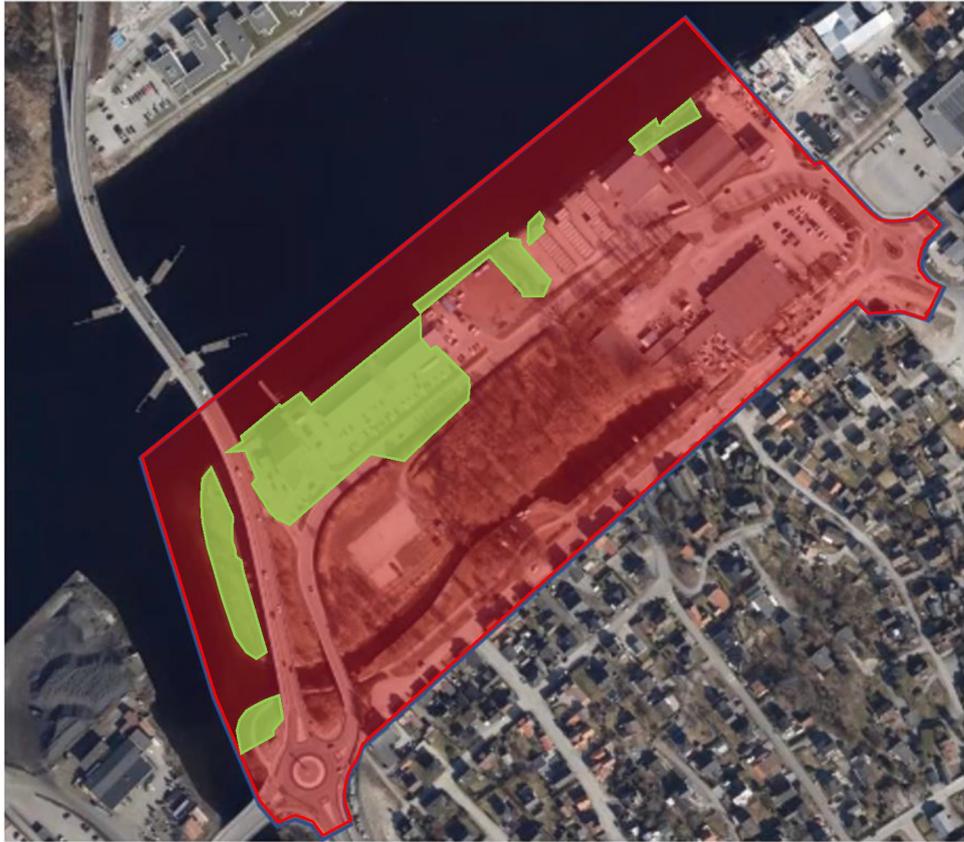
fig. 21: Above: Risk map for aerial bombs in the project area (red: very high risk; purple: very high risk under the backfill package). Below: Risk map for rockets in the project area (red: very high risk).

There is a very high risk of encountering Allied M43 and MC bombs of 500 lbs in the entire project area, except along the banks where soil was brought in after the war. In these bank areas, there is only a high risk for the soil under the backfill packages (see fig. 21). The average penetration depth of aerial bombs is up to 7 m below the 1943 ground level.

3-inch rocket projectiles (RP-3) may be found in the entire project area (except in the post-war backfilled areas) (see fig. 21). The average penetration depth of rocket projectiles is up to 2 m below the 1943 ground level.

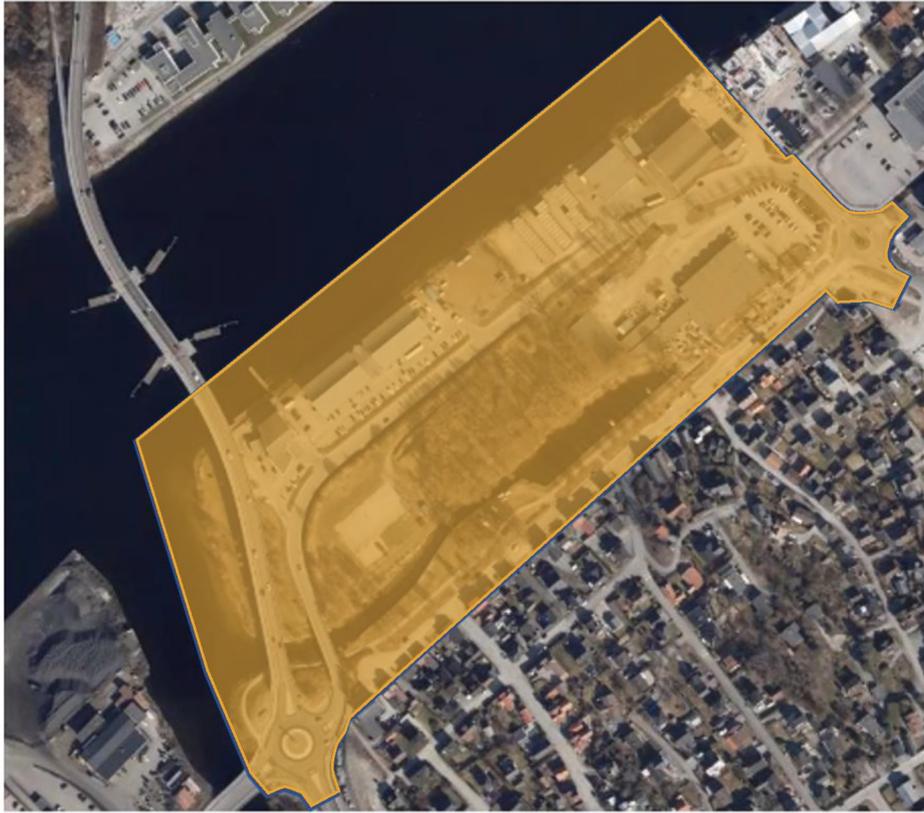
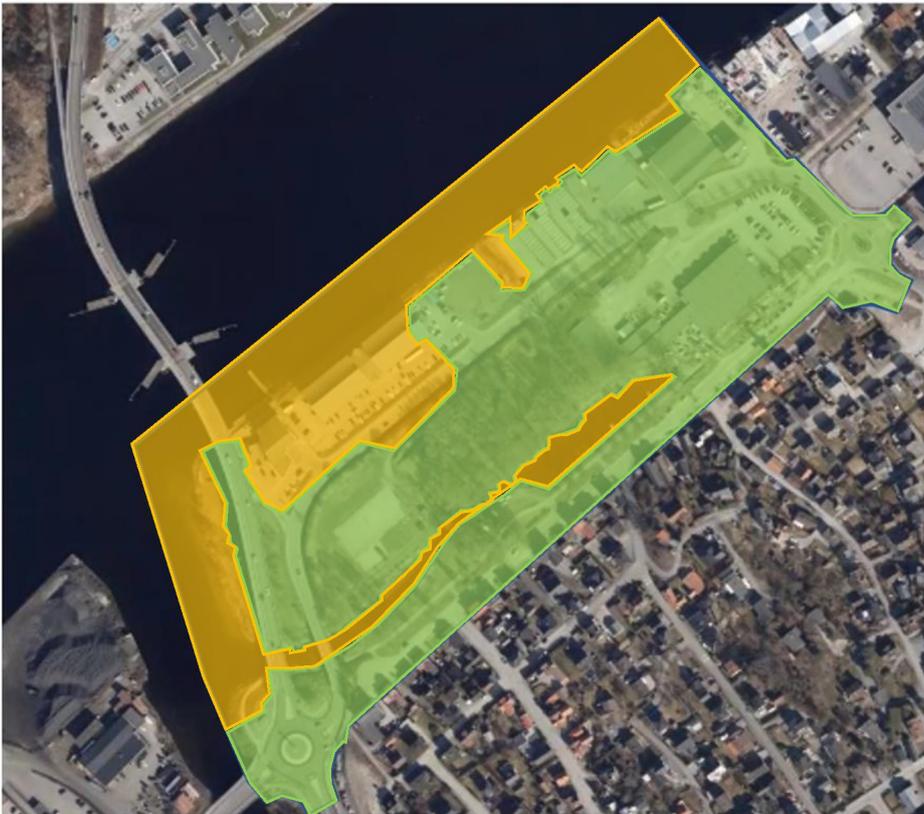
fig. 22: Above: Risk map for artillery ammunition (orange: high risk).
Below: Risk map for mines in the project area (orange: high risk).

There is a high risk of encountering German grenades of 8,8 and 10,5 cm in the entire project area (see fig. 22). That's because the project area is situated within a 500 m buffer of several former anti-aircraft guns, both southwest and northwest of the area. (In July 1943, a German battery was set up on the Roligheten quay on Herøya. In April 1945, anti-aircraft guns were placed on moored ships and a workshop roof in Porsgrunn.) The average penetration depth of artillery ammunition is up to 4 m below the 1943 ground level, except in the post-war backfilled areas, where the entire volume of supplied soil may be contaminated with ammunition.

British A Mk V and VII mines of 1000 lbs, and I-IV and VI mines of 2000 lbs may be found in the water features of the project area (see fig. 22). They are usually located on the seabed or in the soft silt layer. Due to silting, the mines can be 2 to 3 m deep below the 1943 ground level. Mines may also be found in the project subareas that were backfilled after the war.
