Herøya Industripark - Porsgrunn

Historical Research on the Possible Presence of Unexploded Ordnance

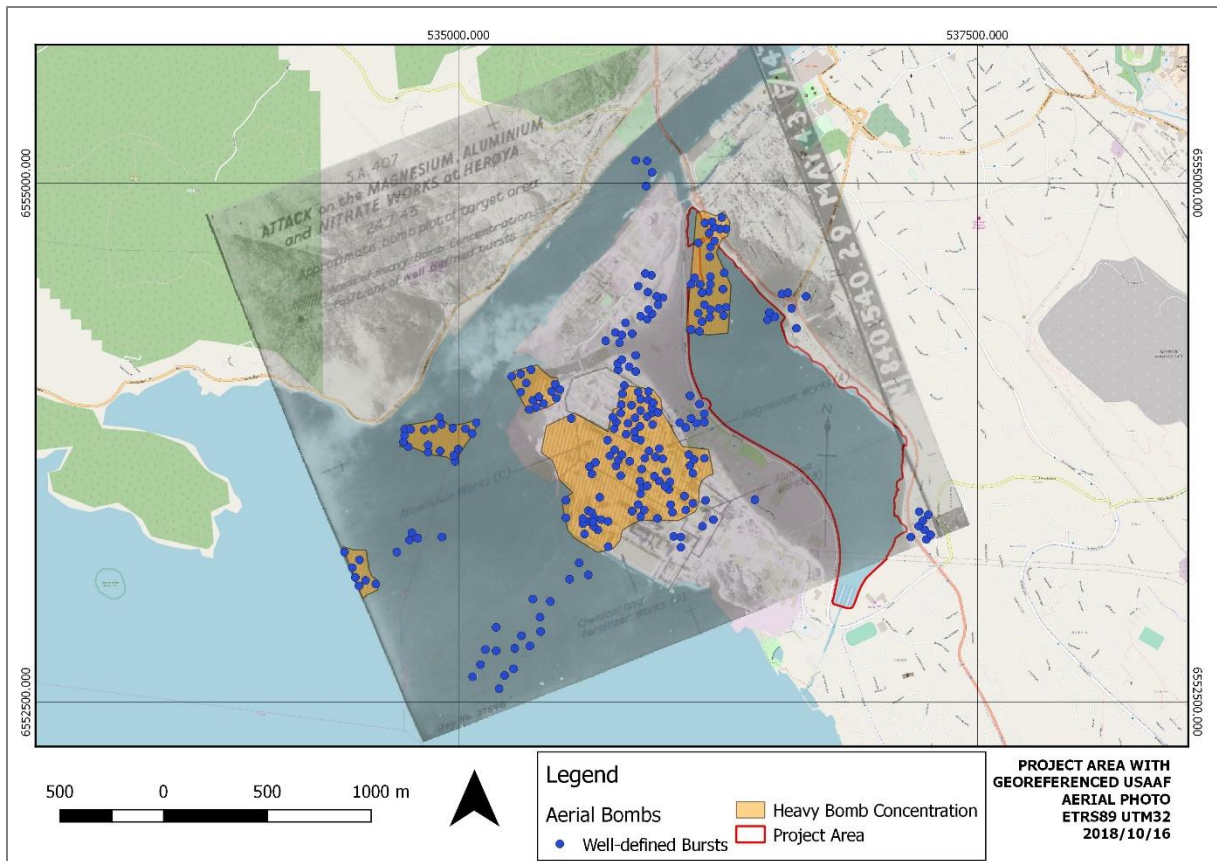
Figure 7: Map of project area with aerial photo from Figure 6 georeferenced and superimposed. Note the blue dots of well-defined bursts and orange areas of heavy bomb concentration (ADEDE and USAAF Interpretation Reports)

The aerial photo from the USAAF Interpretation Report No. SA-407 (shown in Figure 6) was georeferenced and then superimposed over a current map of the project area. The bomb bursts and areas of heavy concentration were traced over so as to be easier to read (see Figures 7 and 8). If the blue dots (each showing a “well-defined burst”) in the Gunneklevfjord are counted, then a total of 25 well-defined bursts landed in the fjord itself. Even if each blue dot would only represent a single bomb, that would add to a total 12,500 pounds of explosives (each bomb being 500 lbs). However, that is not taking into account the fact that the Gunneklevfjord used to be larger (see Figures 9 and 10 for comparison). The peninsula was expanded in the meanwhile since WWII. Observing the aerial photo from Figure 6, and counting the number of dots that fall into the former fjord, the number rises from 25 to 42. If each dot is still only one bomb, that would amount to 21,000 pounds of explosives (see Figure 10).

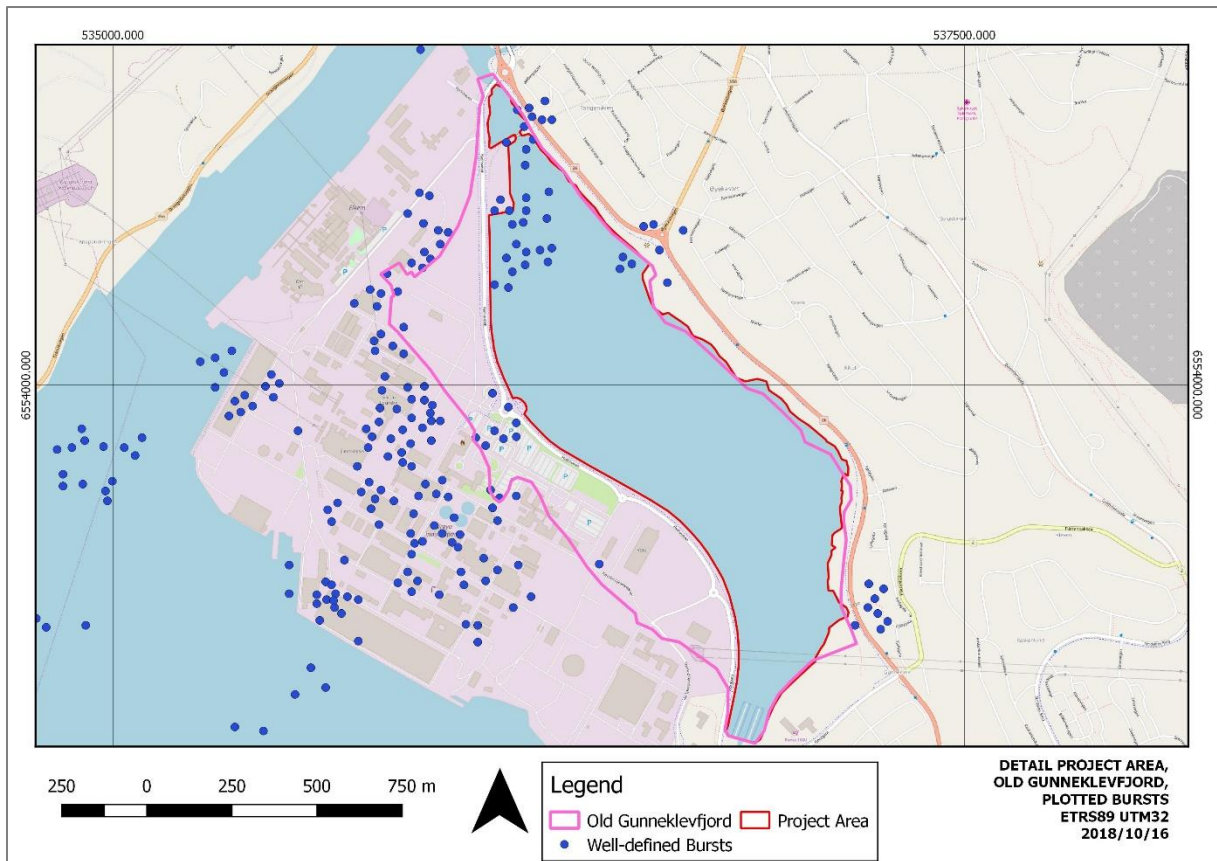
Figure 10: Detail map showing the project area in red, the old Gunneklevfjord in pink, and the plotted bombs from the USAAF report picture. (ADEDE and USAAF Interpretation Report)

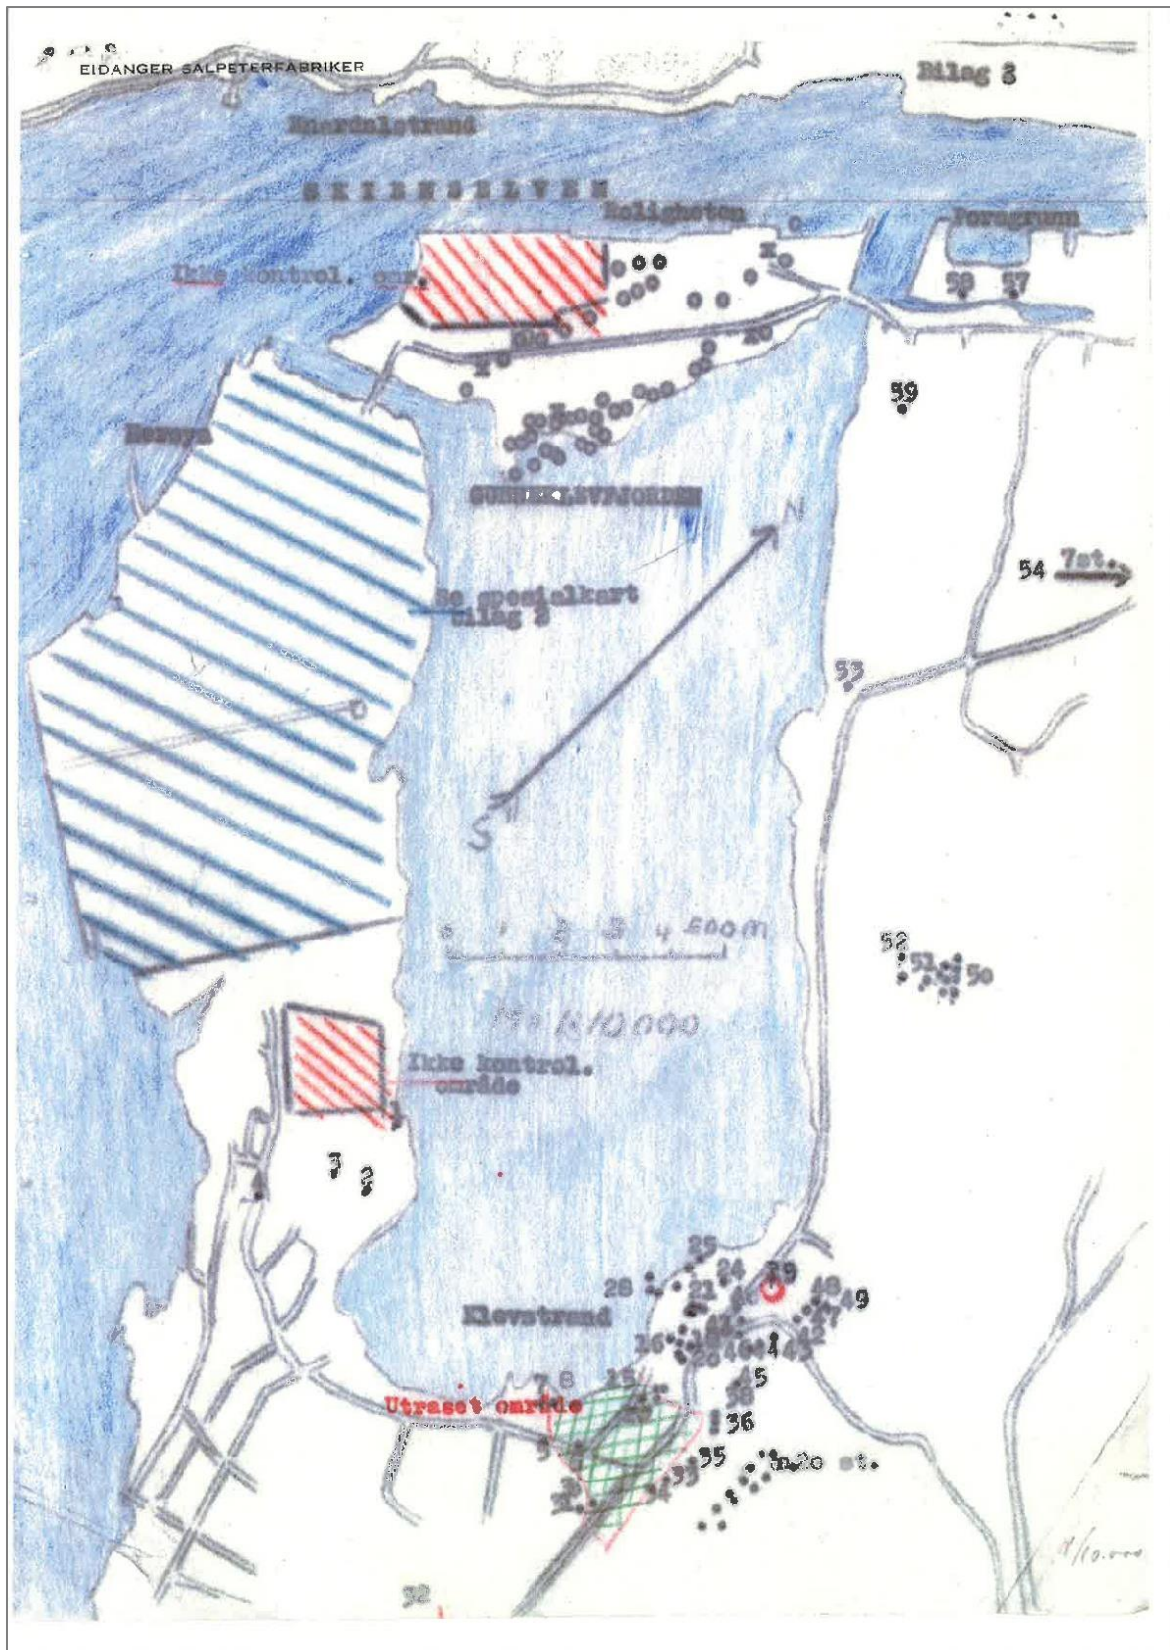
The Eidanger Salpeterfabrik report also mentions the landslide at Gunnekevfjord, in the appendices listing damage and bomb craters in the area of Gunnekev: "*Terrenget er sunket ned langs fjellsiden ca 8 m.*"²⁷ In addition to this, in a sketch of the Gunnekevfjord included in the report, the cluster of bombs in the southeast is clearly depicted. There is also a hatched area with the note "*Utraset område*".²⁸

Figure 18: Sketch included in the report issued by Eidanger Salpeterfabrik. Note the hatched area in the south of the fjord, with the words "Utraset område". This was probably the location of the landslide. *Rapport fra Eidanger Salpeterfabrik*

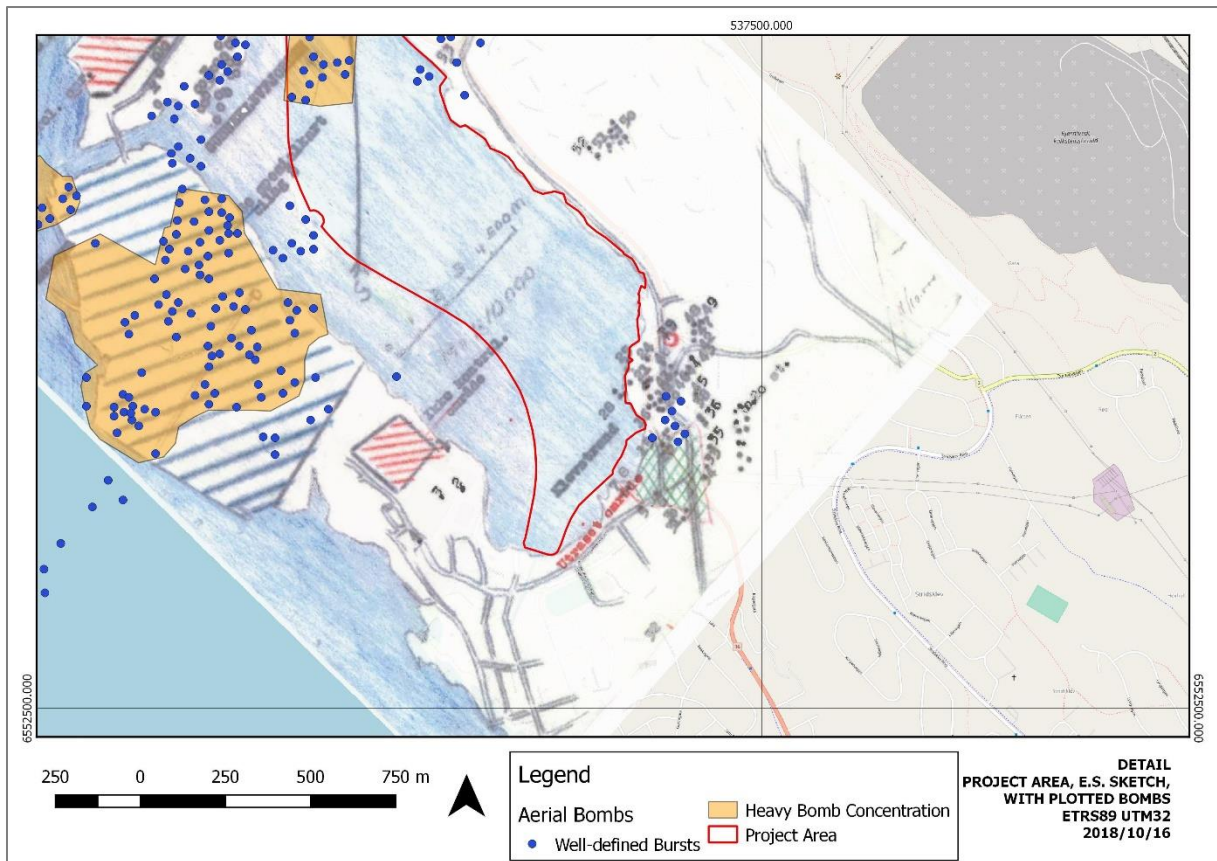
Figure 20: Detail of Figure 19, with the plotted bombs from the USAAF report superimposed.
(ADEDE, USAAF Interpretation Report, Eidanger Salpeterfabrik)

It can be concluded that there exists the possibility of UXO having ended up in the southern part of the Gunneklevfjord. More than one source refers to the considerable landslide, a landslide directly caused by the bombing of 24 July 1943. Since no methodical clearance of the Gunneklevfjord has yet been performed, the risk of encountering unexploded ordnance in the fjord is high.

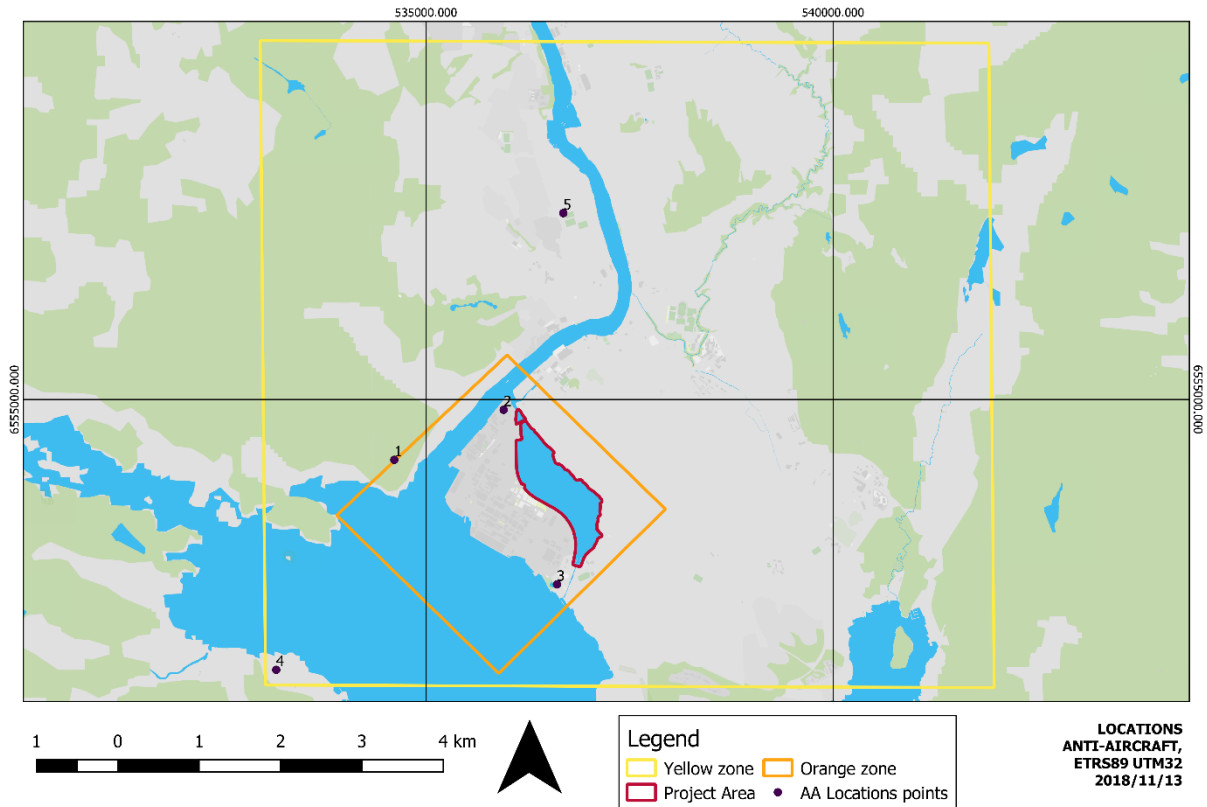
Figure 22: Locations of anti-aircraft artillery. 1: Torsberg, 2: Roligheten, 3: Hydro Kasino, 4: Herre, 5: Tollnes (*ADEDE and HP Eiendom A/S*)

As can be seen in Figure 22, three of the locations (1, 2, and 3) fall inside the orange zone, in the close vicinity of the project area of the Gunneklevfjord. The two locations at Herre and Tollnes are located within the yellow zone. While not adding to the risk analysis of the current project area, should any future works expand, these two anti-aircraft locations should certainly be taken into account. However, the anti-aircraft locations at Roligheten and at Hydro Kasino are located within 500 meters of the Gunneklevfjord.

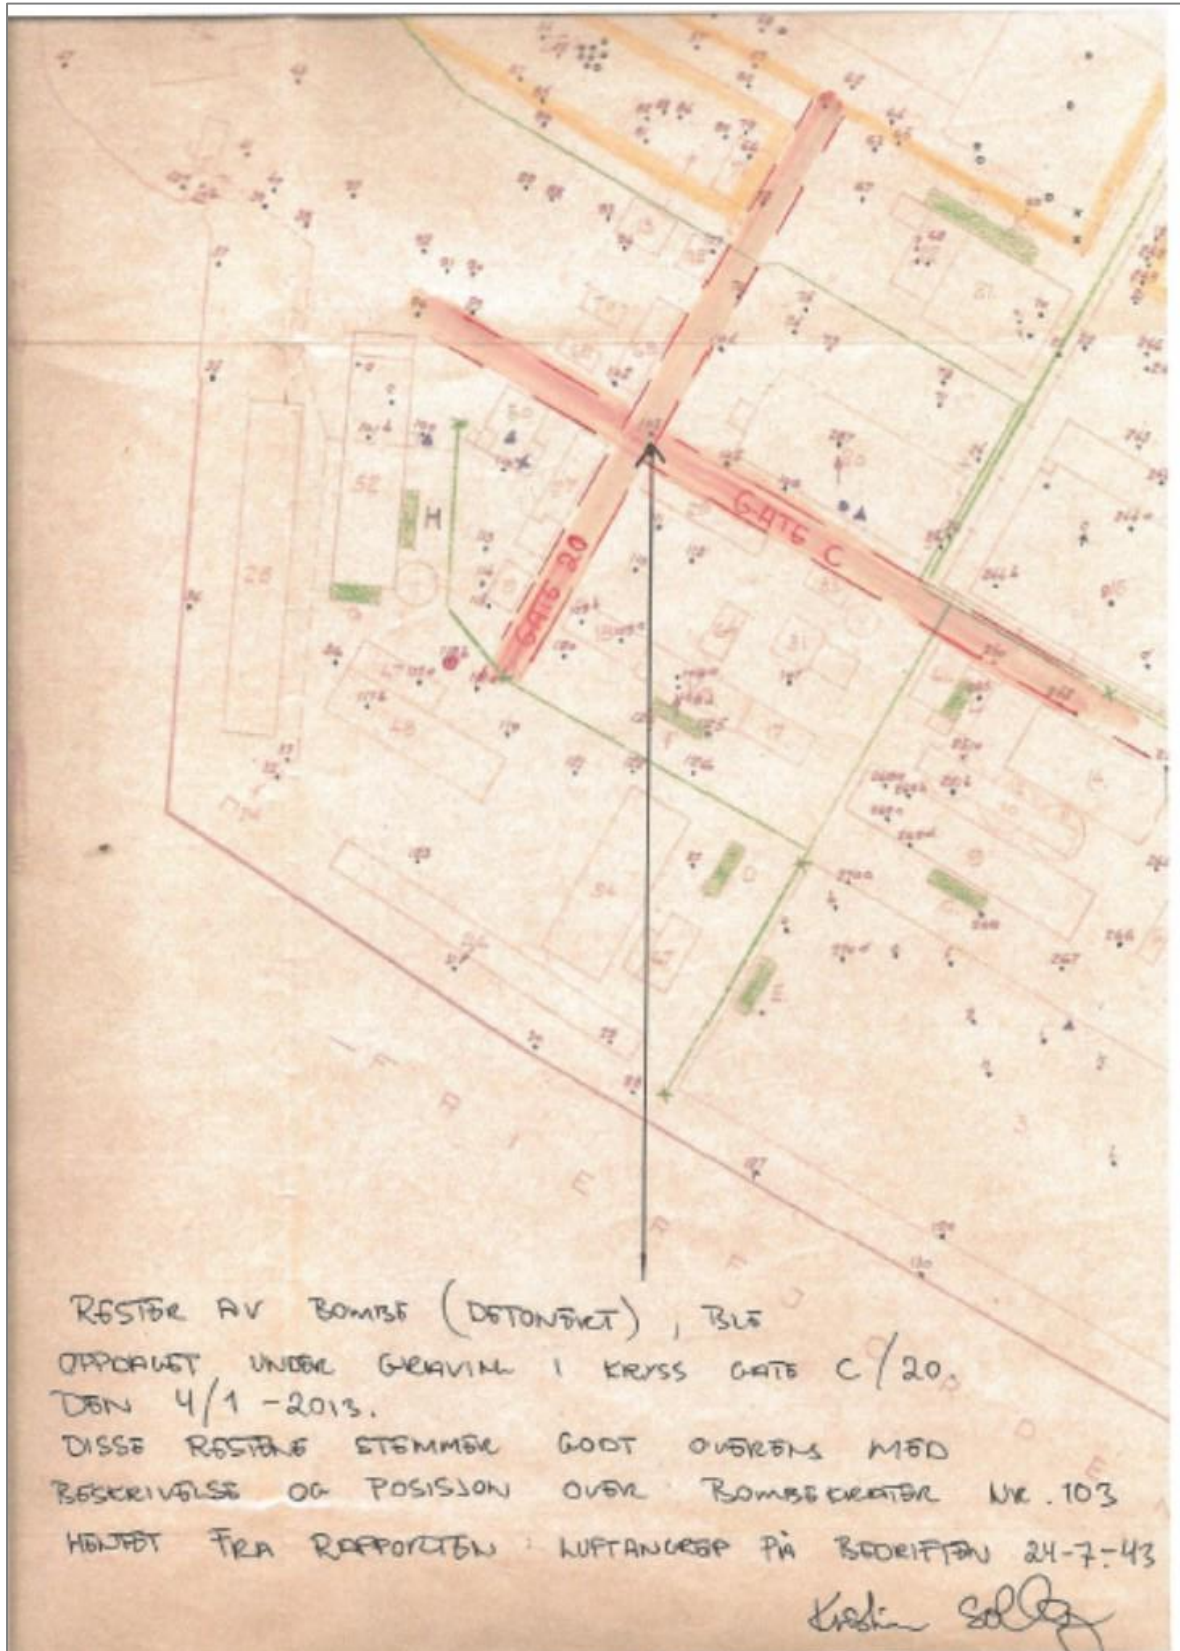
- On the 4th of January 2013 parts of a (detonated) bomb were discovered when digging at “crossroad C/20” (see Figures 33, 34 and 35). This confirms that the position of “crater 103”, as described in the report released by *Eidanger Salpeterfabriker* is fairly accurate.
- On the 25th of July, 1943, German AA projectile splints were recovered from a beach (Figure 35).
- On the 14th of September 1982 an Impeller from the fuse of a US bomb was found.
- In 1982/83, the industrial park reported the discovery of parts of US 500 lb bomb, as well as splints. These were found in a storage at Herøya during a clean-up.

Figure 33: Appendix to report from Eidanger Salpeterfabriker, describing the location of discovered UXO after the 24 July attack⁶²

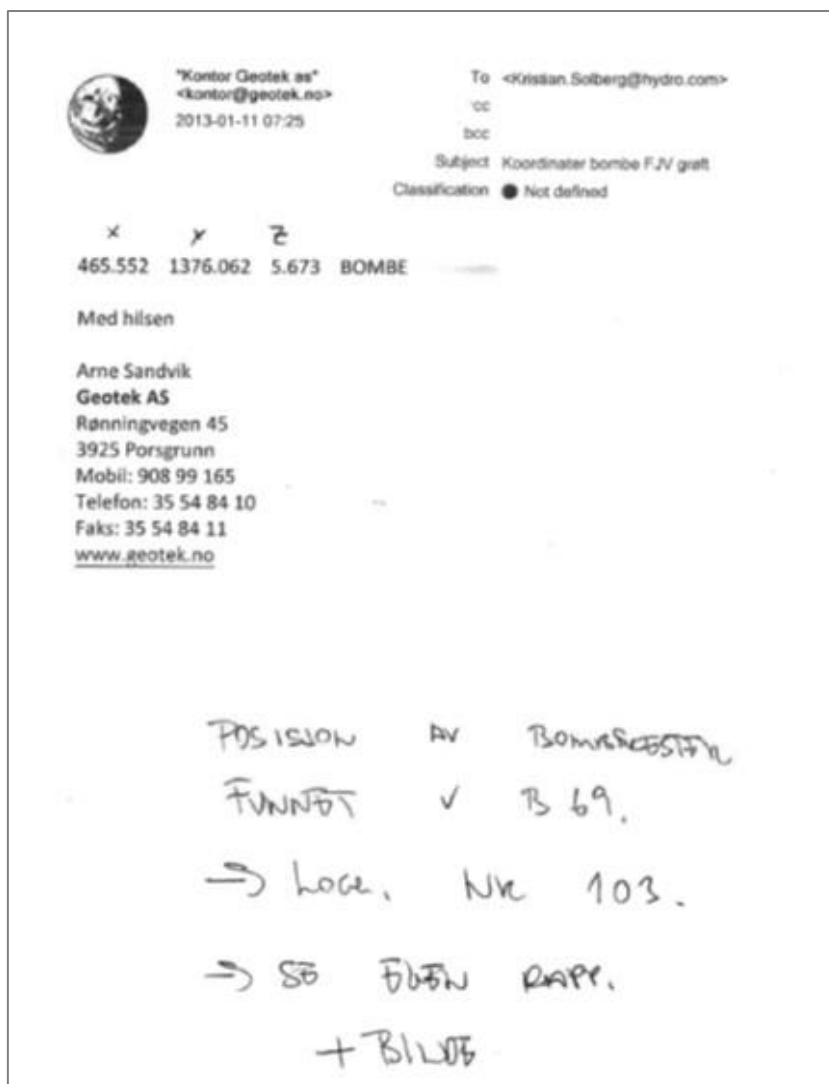
Figure 35: Report of bomb discovered on the 4th January 2013⁶⁴

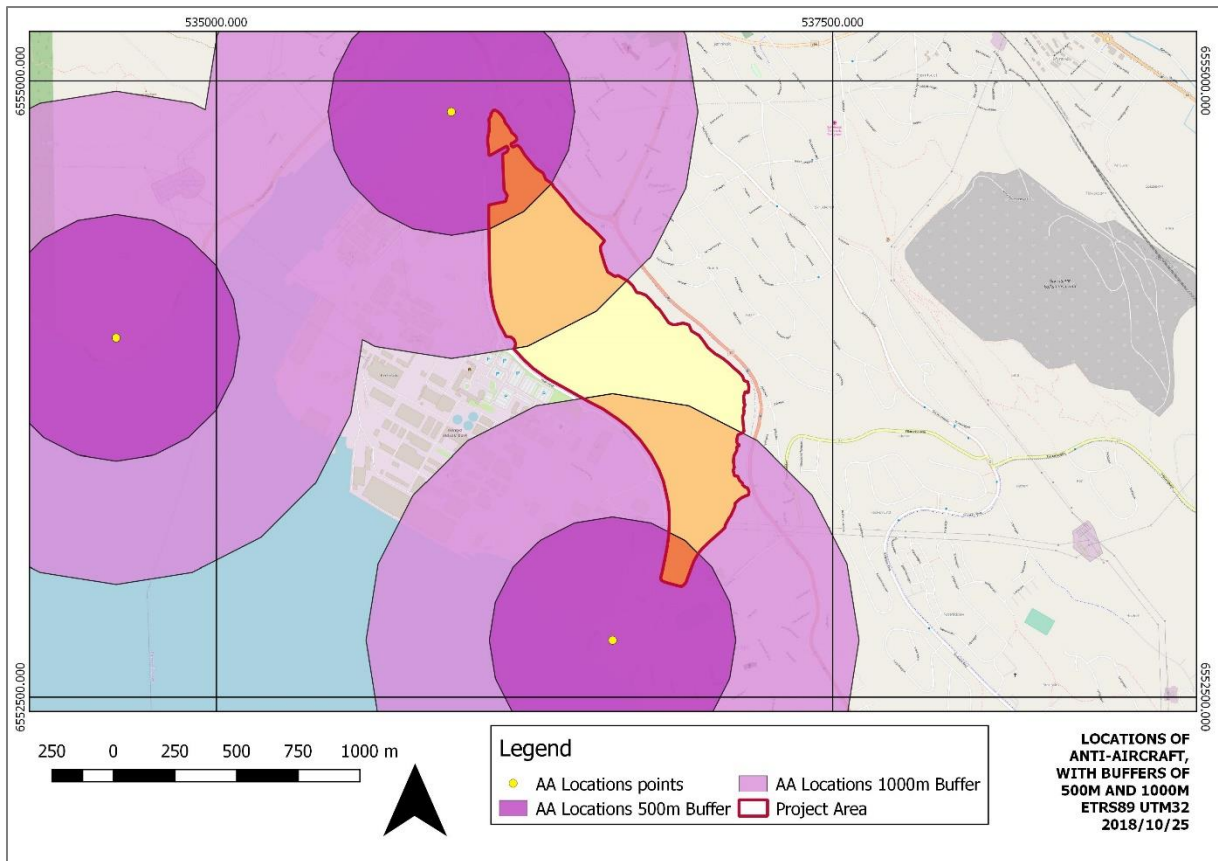
The buffer of 500m from the anti-aircraft locations was given a risk attribution of High, while the larger buffer of 1000m was given a risk attribution of High Average. The part of the project area which the buffers did not cover was given a risk attribution of Average.

Figure 41: Map showing anti-aircraft locations with buffers of 500m and 1000m. (ADEDE)
