E18 Langangen - Rugtvedt

Parcel 2

Draft Geotechnical Report

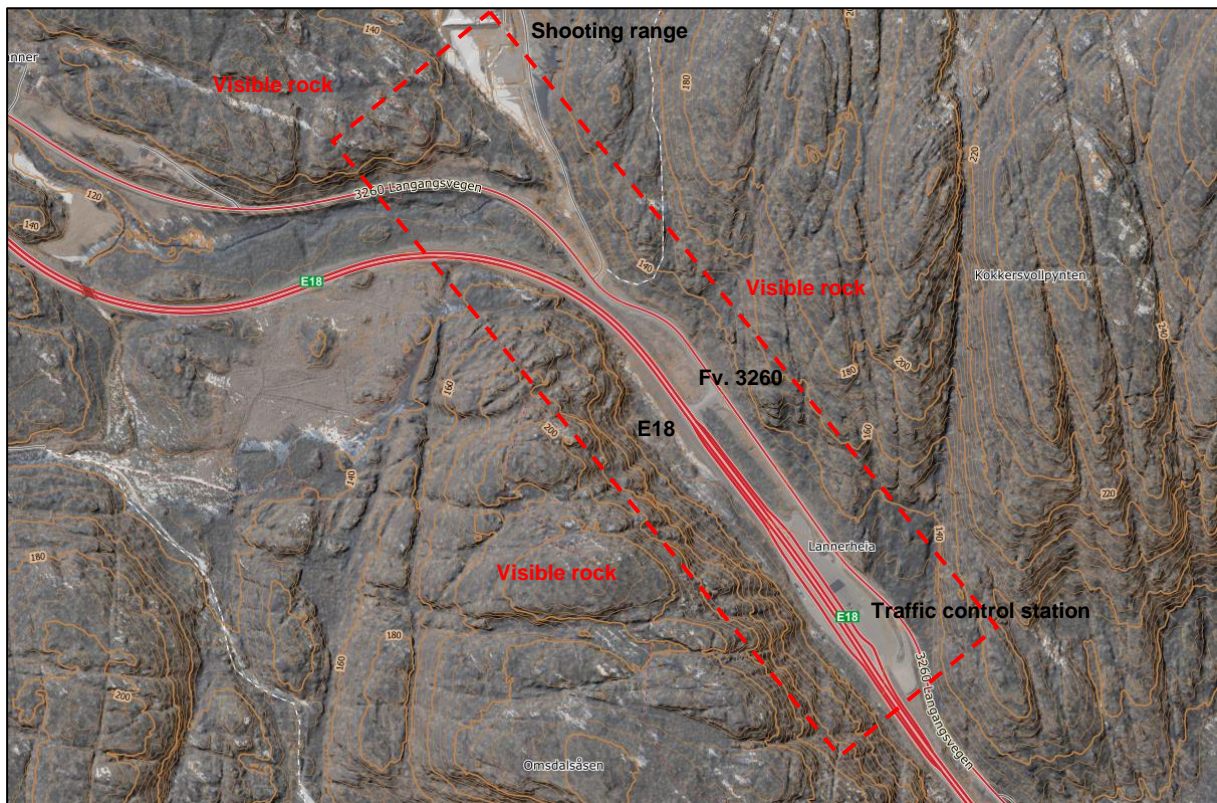
The main infrastructures in the area are E18, country road 3260 (which goes between Skjelsvik and Langangen), a traffic control station, and a shooting range. There are few or no settlers in the area. The terrain level for existing roads is relatively flat, in general around +129 - +130 but increases in the areas with visible rock. Terrain map from *Kartverket* (“Norwegian Mapping and Cadastre Authority”) for the area can be seen in Figure 1.

Figure 1 terrain map from hoydedata.no

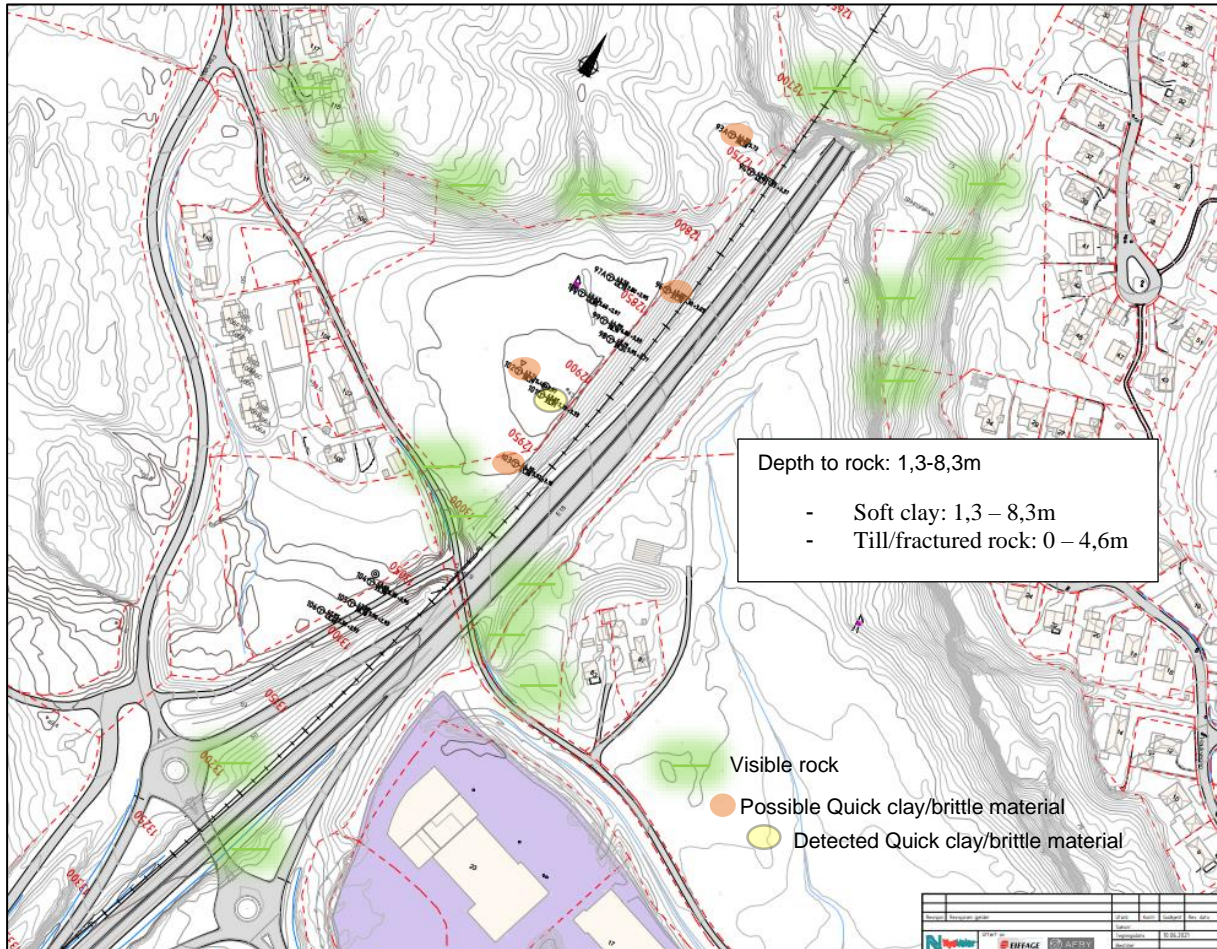
Around ch. 12/680 – 12/950, north of Friervegen, boreholes are indicating soft clay that could be sensitive and quick but with limited depth. After Friervegen the soil conditions gradually improve with more solid soil and visible rock to the end of the line at ch. 13/500.

Figure 12 Soil conditions Kjørholt

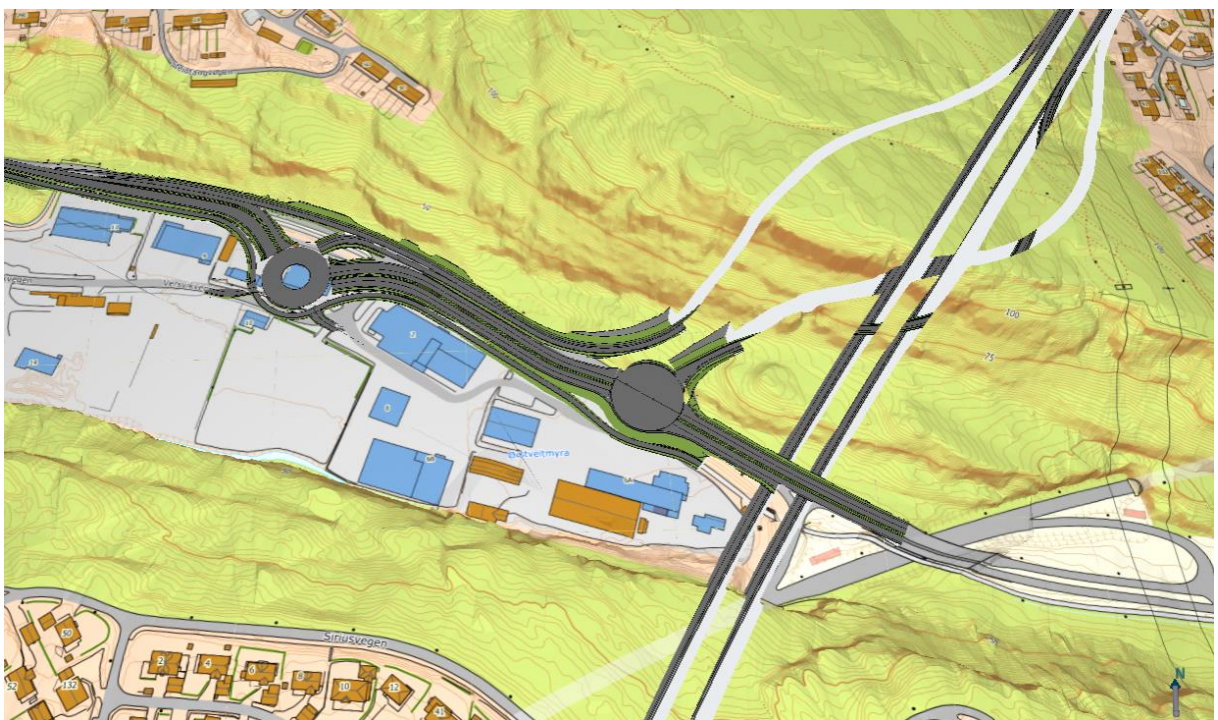
Figure 18 Planned road Skjelsvikdalen – 3D model

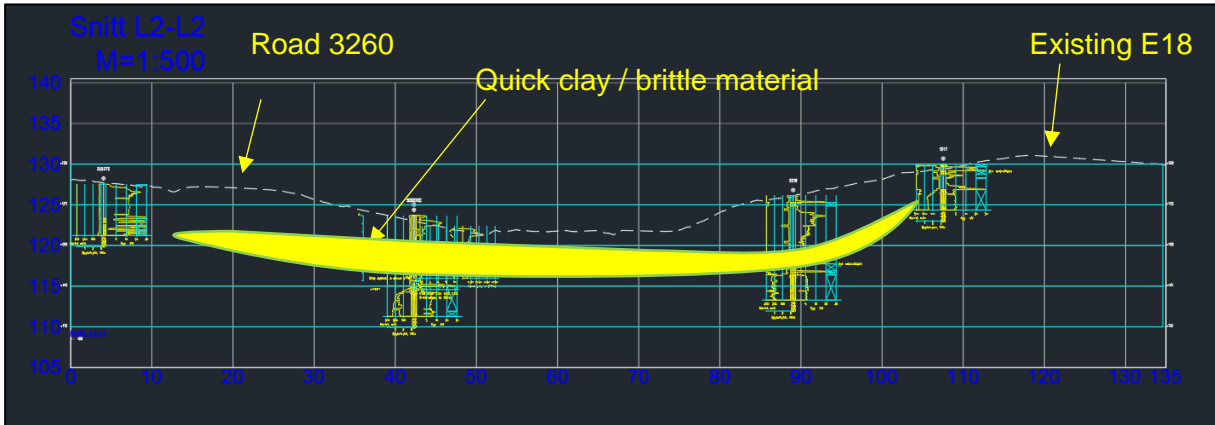
Figure 26 Profile cross-section L2-L2

Terrain slopes are less flat than 1:20. This cross-section will be investigated further.

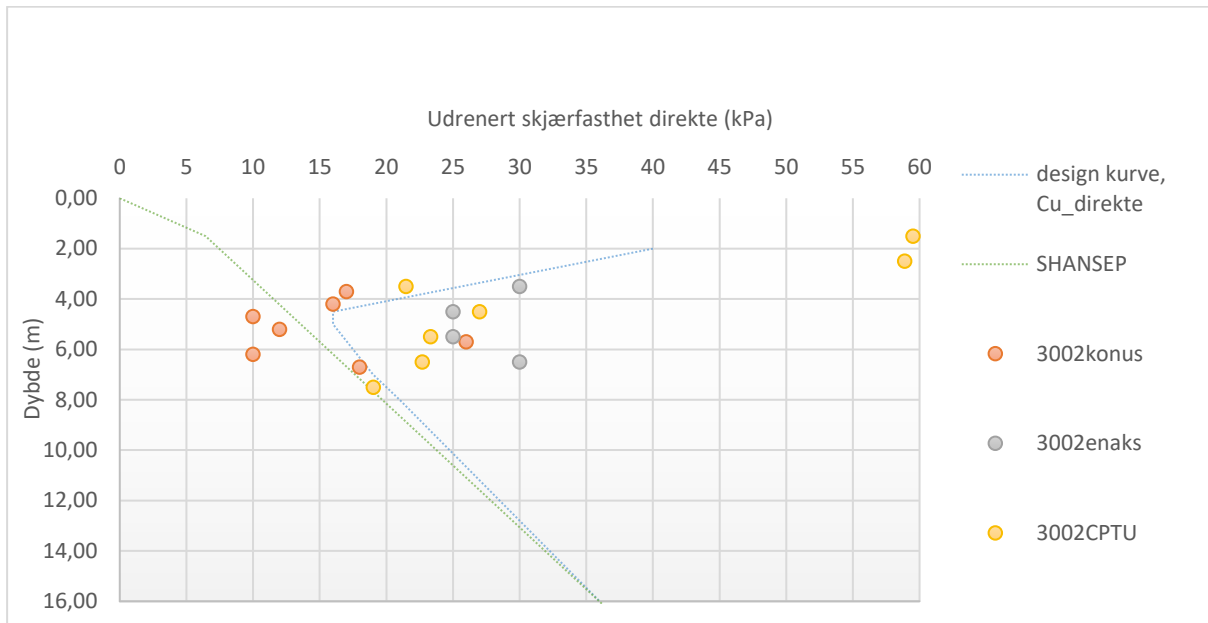
A compilation of undrained shear strength, direct in the area is shown in Figure 31.

Figure 31 Undrained shear strength

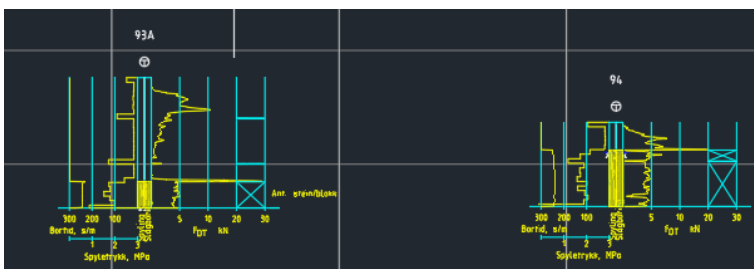
Figure 39 Boreholes cross-section C-C

Possible quick clay / brittle material in borehole 93A. But closest borehole, 94 does not conclude sensitive clay so most likely sensitive local around 93A. After that, the surface level is flatter than 1:20 so no risk for landslides due to terrain conditions. Height difference in the surface due to construction of the existing E18 in the area.

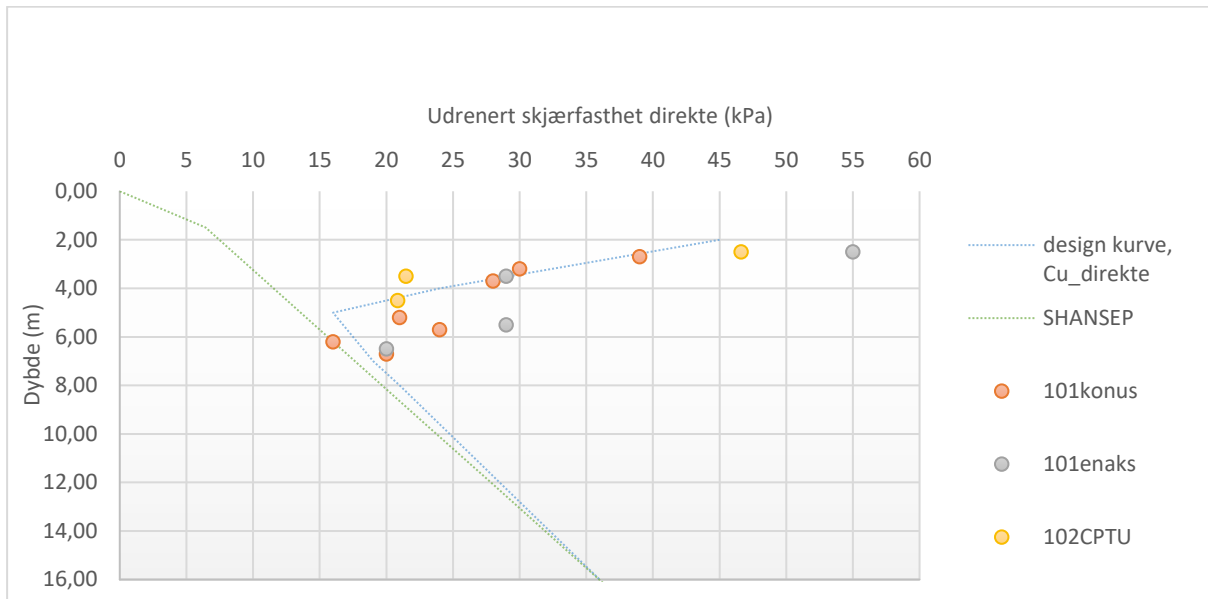
Figure 47 Undrained shear strength

A compilation of undrained shear strength, direct in the area is shown in Figure 47.
